Reconstruction Era National Historical Park Accessibility Assessment

Summary Report

Gary Everhardt Park Break Program

July 2023

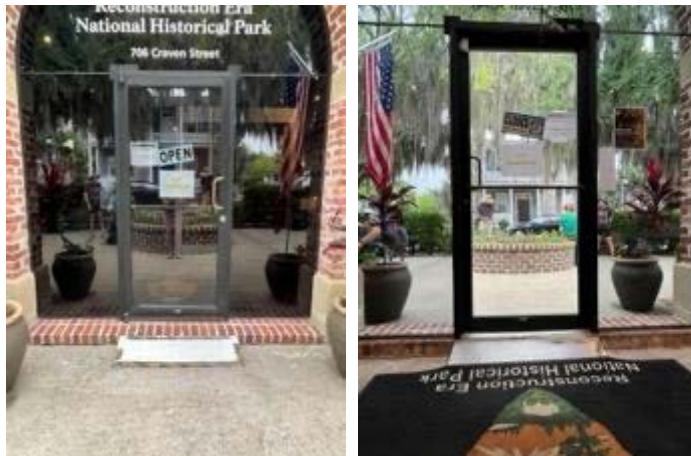
Deficiency: The front entry to the Firehouse has several deficiencies. The vertical rise on the brick to the front entrance door is 3 inches. The front entrance also has a temporary ramp outside with a slope of 26.2 percent and a temporary ramp from the exterior door inside of 24.3 percent.

Recommendations: Consult with design and landscape services to design a new ramp with materials in kind to meet minimum requirements for accessibility. Elements of the redesign to take into consideration include, but are not limited to, the following:

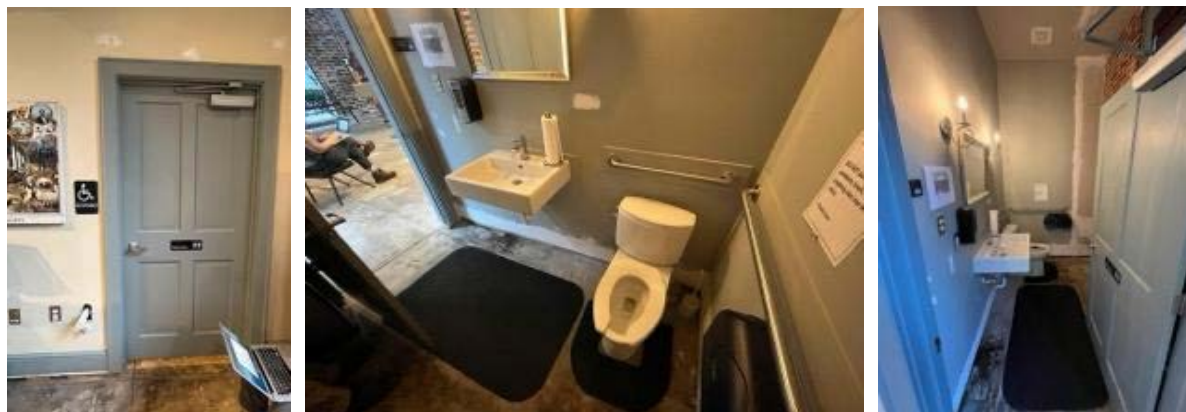
Deficiency: The accessible toilet compartment in the bathroom at the Firehouse has multiple deficiencies. The unisex signage on the door for the bathroom does not contain the required raised characters or braille and does not meet the 48 inches height standard. The light switches were measured at 54 inches from the floor to the usable part. The bathroom mirror height was measured at 56¼ inches which does not meet accessibility requirements. The pipes under the sink are not wrapped. The doorway entry and minimum maneuvering clearances at the entry door and swing of the door is impeded by the sink with a minimum clearance of 23 inches which does not meet minimum clear floor space requirement. The rear grab bar exceeds the maximum wall gap requirements at 1¾ inches. The rear grab bar exceeds the maximum height from the finished floor at 37¾ inches. The length of the rear grab bar is less than the minimum acceptable length and was measured at 25 inches long. The side grab bar length is less than the minimum required measuring at 37 inches long. The height from the finished floor measured at 37¾ inches high, which exceeds the maximum height requirement of 36 inches. The coat hook

Recommendations: Consult with design services to reconfigure the designated accessible restroom in the Firehouse Visitor Center to meet accessibility requirements. When consulting the design services the following accessibility requirements shall be taken into consideration:

Further recommendations include the following: reversing the swing of the door and approach to bathroom door to be a pull door, opening into the common area, with a minimum of 60 inches perpendicular to doorway and 18 inches minimum parallel to doorway, including a clear floor space that is 30 inches, minimum by 48 inches minimum (305.3) with a forward approach from inside the bathroom.

clearance of 27 inches above the ground surface for a minimum depth of 8 inches at the wheelchair space. To avoid injury or burns, water supply and drainage pipes under lavatories and sinks must be insulated, enclosed, or configured to prevent contact and shall cover any sharp or abrasive surfaces.

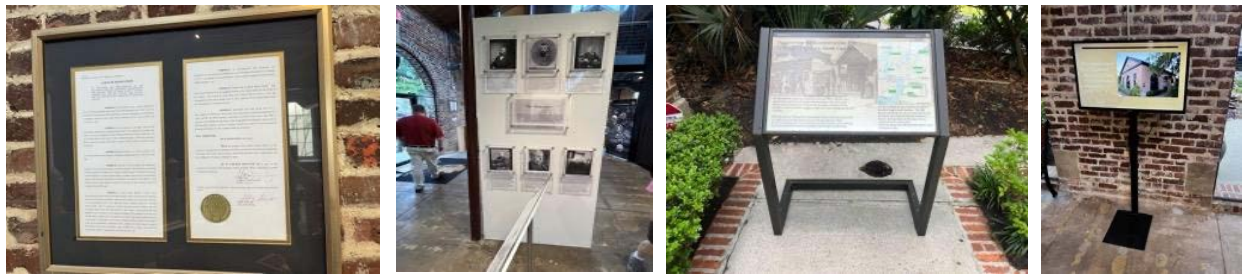
Deficiency: There are multiple deficiencies in the presentation of interpretive exhibits and signage at the Old Beaufort Firehouse. The variety of exhibits is heavily visual and textual with no touchable and interactive experiences. These exhibits include the following on the building's exterior; the bench on the north side of the Firehouse, standing park sign for the visitor center, cultural district sign, and two plaques on the Firehouse building. Additionally, the following exhibits are inside the Firehouse: art installation interpretation sign, three wall exhibits, one standing horizontal exhibit, framed Senate resolution on west wall, wall canvas, reconstruction map, two retractable banners, and two waysides. Many of the photos and labels are difficult to

Recommendations: Park management shall work with design services to investigate a comprehensive redesign of interpretive exhibits and panels throughout the exterior of the Old Beaufort Firehouse. When panels and/or exhibits are replaced, ensure that the information is presented in a way that is accessible to the widest range of visitors. Things to consider in interpretive design include the use of sans serif or simple serif fonts (as opposed to non-uniform text fonts and size), minimal use of italics, contrast between text and background of 70 percent to 95 percent, and the incorporation of audio and tactile elements. Text should not appear over images or in shadow as the stylistic presentation of information can interfere with readability. Additionally, tactile experiences are essential to people with visual impairments and can assist in conveying the interpretive message to many people with cognitive disabilities. Select tactile objects and models that provide a coherent explanation of the exhibition topic and provide an equal opportunity to understand what is displayed in exhibit cases or behind barriers. Include these tactile exhibits in the audio described tour recommended in a separate work order.

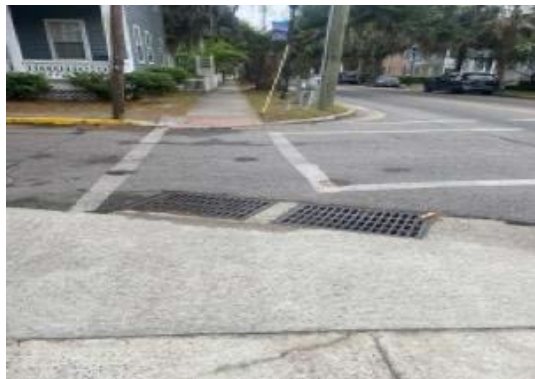
Deficiency: The north side accessible route to the Old Beaufort Firehouse has two drainage grates with openings 1½ inches wide. The openings to the drainage grates run parallel with the path of travel. There is no detectable warning present.

Recommendations: Grade the sub-base and replace the existing concrete path. When grading and replacing the concrete path, ensure that the cross slope along this route does not exceed 2.08 percent, the running slope does not exceed 5 percent, and that there are no changes in level in the ground surface greater than ¼ inch high.

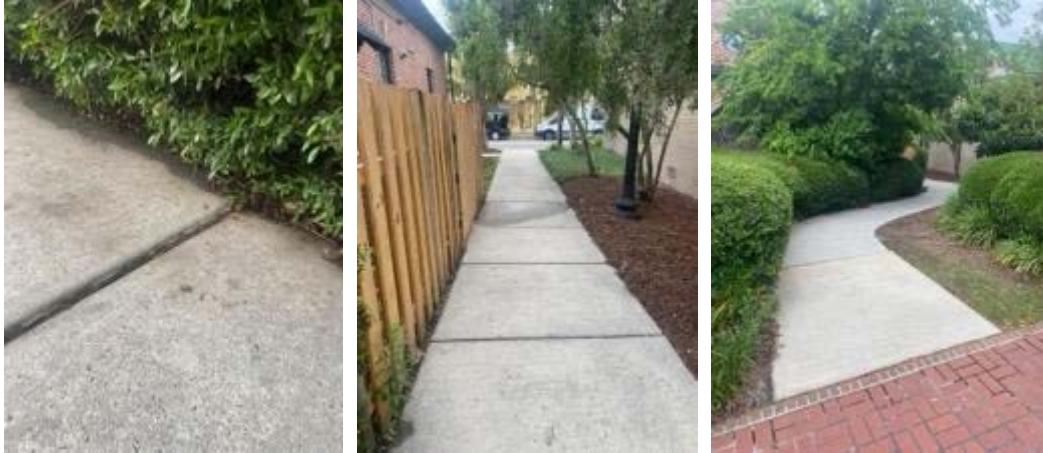
Deficiency: The accessible route on the east side of the Old Beaufort Firehouse has multiple deficiencies. The maximum running slope of the curved sidewalk was measured to be 8.1 percent and the cross slope was 4.8 percent. The sidewalk section with non-compliant slope from brick pavers to 45 feet 3 inches to the curve had a width of 71 inches. The vertical change in the level of the sidewalk at 21 feet was 1¼ inches.

Recommendations: Replace the sidewalk and grade the ground surface. When grading, ensure the concrete sidewalk cross slope does not exceed 2.08 percent, running slope does not exceed 5 percent, and that there are no changes in level in the ground surface greater than ¼ inch high.

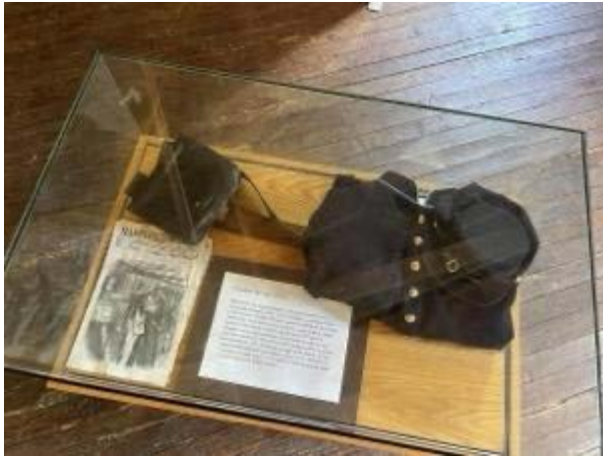
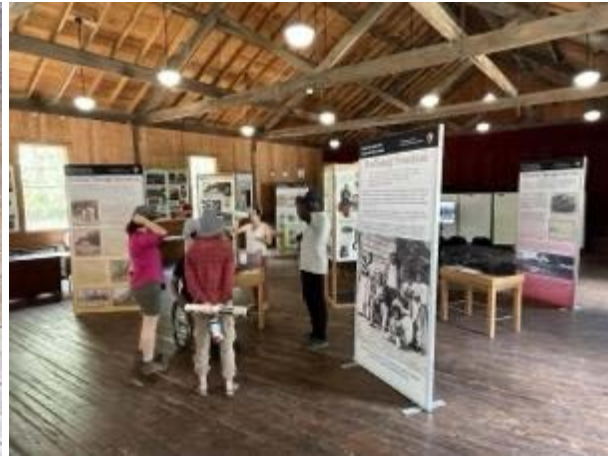
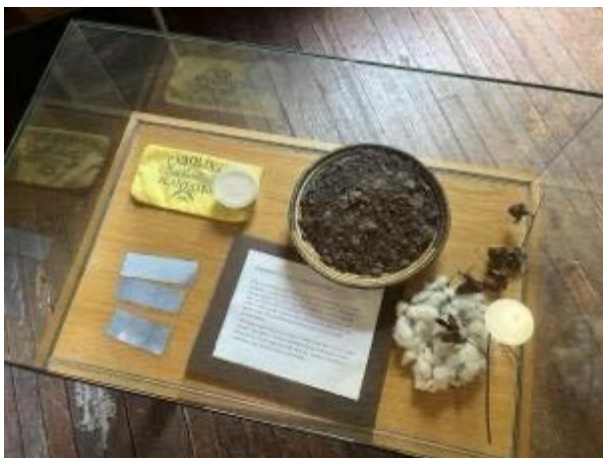
Deficiency: There are multiple deficiencies associated with the interpretive exhibits at Darrah Hall. The exhibits are heavily visual and textual with no touchable and interactive experiences. These exhibits include the four glass case exhibit boxes, four standing informational boards, two four-panel informational panels, one vertical retractable banner, and seven wall posters. The text on much of the exhibit content is too small for the viewing distance. There is non-uniform font, size, and insufficient contrast of text on background. There is also insufficient positioning and lack of audio or tactile elements that create barriers to effective

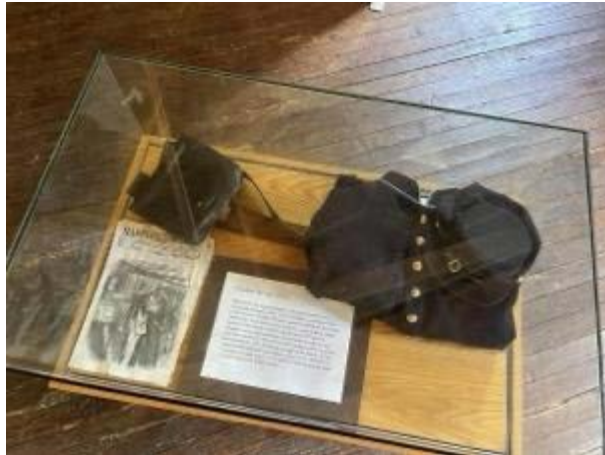
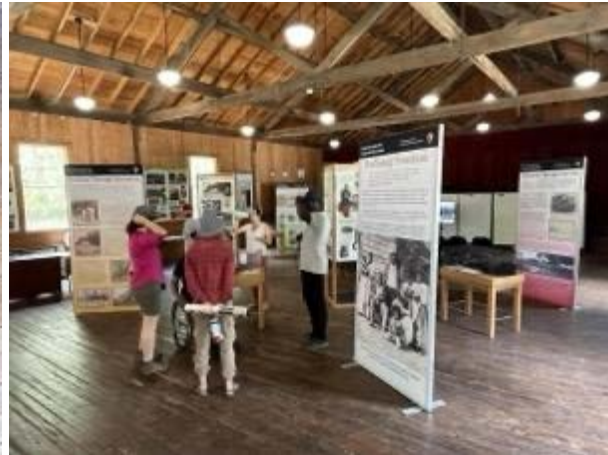
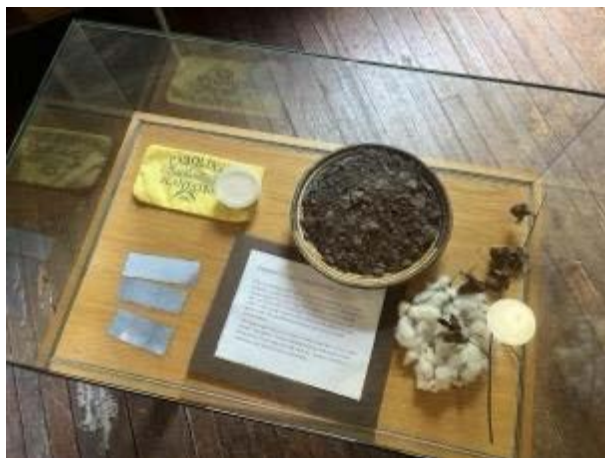
Deficiency: The existing visual elements and features within Darrah Hall and surrounding grounds do not have corresponding audio components or audio description. This presents a barrier to full participation for visitors who are blind or have low vision, and for some individuals with cognitive impairments. While the park does offer ranger-led tours it does not provide a comprehensive audio described tour of Darrah Hall's interpretation including the 4 glass case exhibit boxes, 4 standing informational boards, 2 four-panel informational panels, 1 vertical retractable banner, 7 wall posters and self-guided tour information provided in the park unigrid brochure and mobile application. The video planning at Darrah Hall includes open

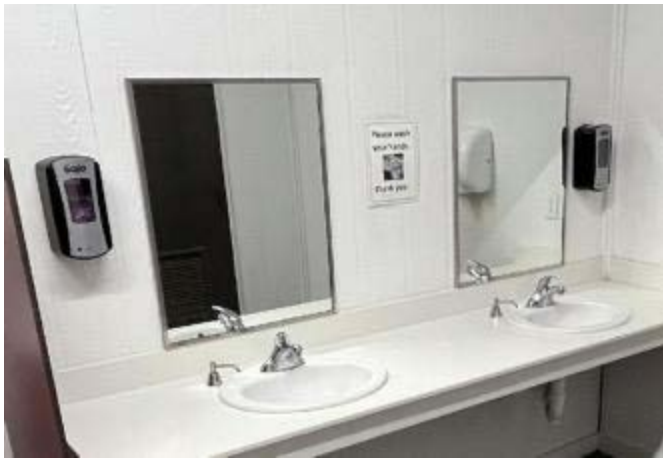
Deficiency: In the men's restroom two of the soap dispensers were measured 16 $\frac{5}{8}$ inches above the sink counter. The height of the counter is 34 $\frac{5}{8}$ inches, which brings the total height of the soap dispenser from the floor to 51 $\frac{1}{4}$ inches. This exceeds the 44-inch maximum height.

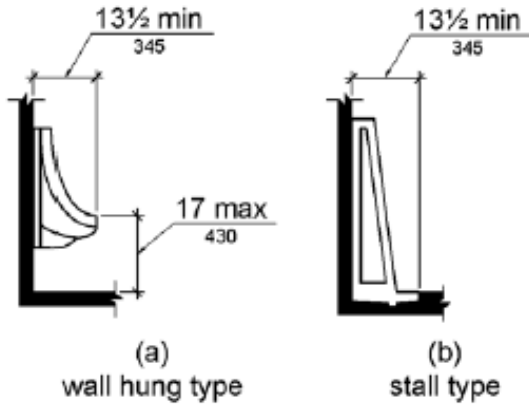
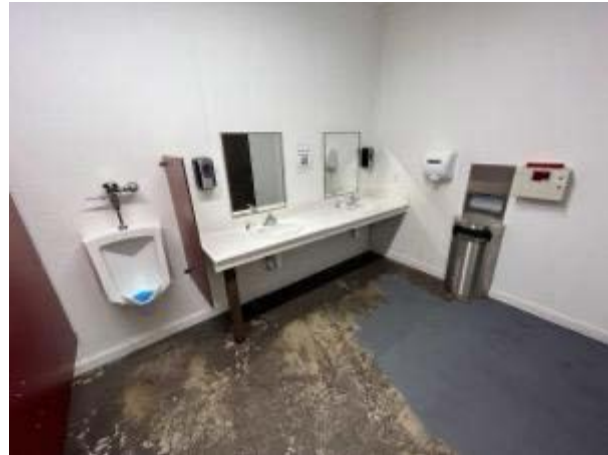
Deficiency: The wall hung urinal in the men's restroom at the Darrah Hall Men's Restroom area exceeds maximum height requirements of 17 inches maximum at 23½ inches above the finish floor to the top of the rim. In addition, the flush handle is 53 inches tall, which does not meet accessibility requirements.

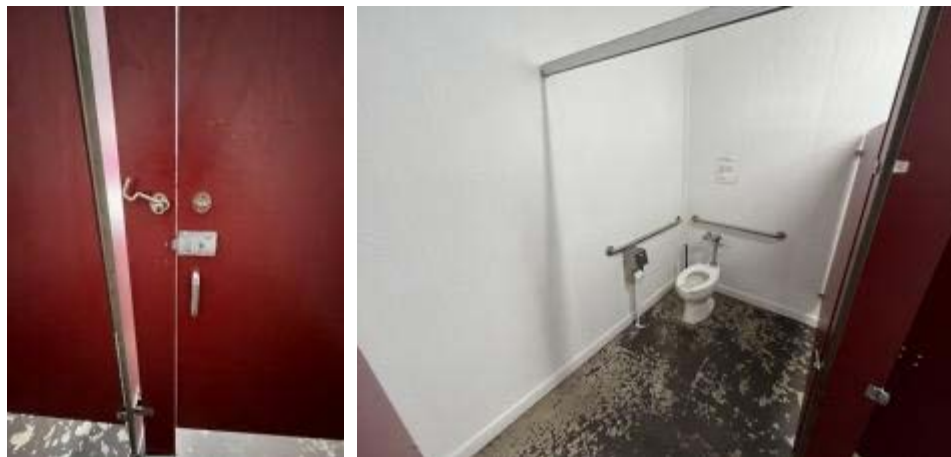
Deficiency: The wheelchair accessible toilet compartment in the men's restroom at the Darrah Hall has multiple deficiencies. The water closet seat exceeds maximum distance requirements at 18½ inches from the side wall to the centerline of the toilet. The latch hook on the toilet compartment door is not operable with one hand and requires tight grasping, pinching, or twisting of the wrist.

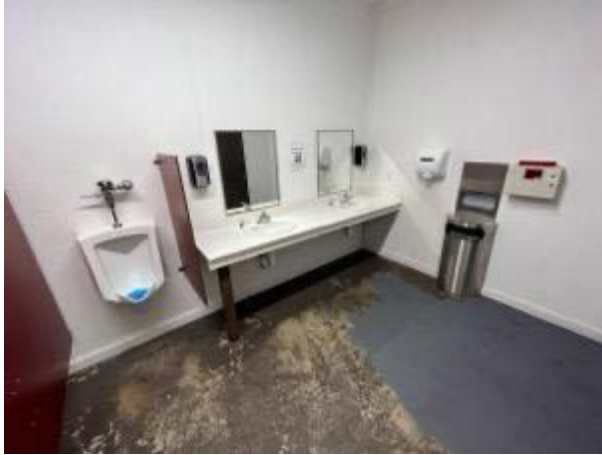
Deficiency: The Sharp Safety container was measured at 54¾ inches from the floor to the usable portion of the container which does not meet accessibility requirements for reach range.

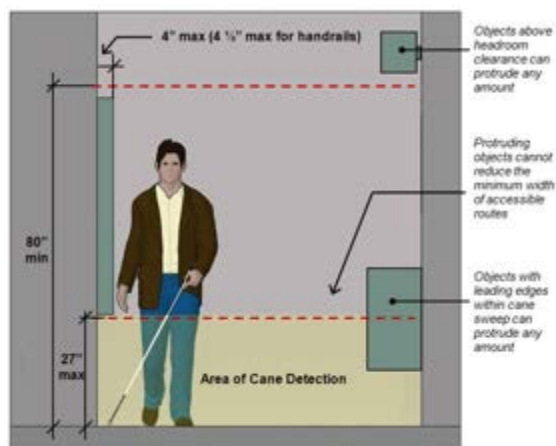
Deficiency: The bottom of the fire extinguisher was measured at 30 inches above the floor and 5½ inches away from the wall, protruding into the path of travel. A protruding object is an accessibility deficiency when the object protrudes more than 4 inches into the path of travel above 27 inches from the finished floor or ground surface.

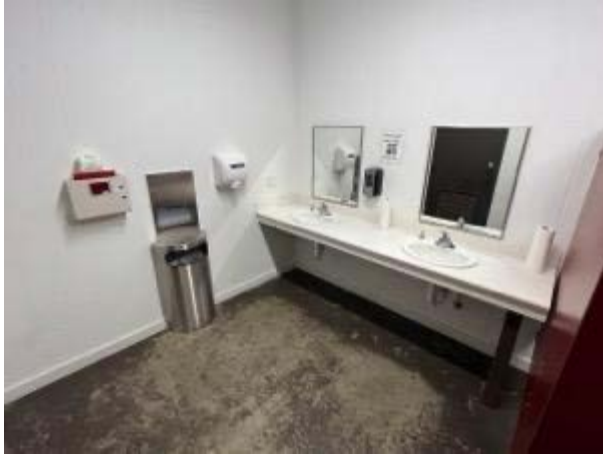
Deficiency: The Sharp Safety container was measured at 54½ inches from the floor to the usable portion of the container, which does not meet accessibility requirements for reach range.

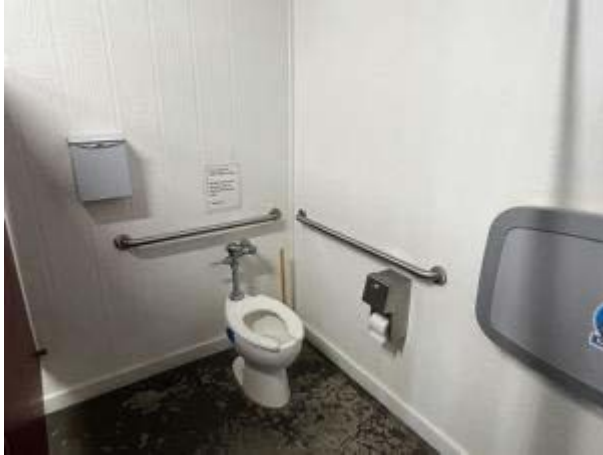
Deficiency: The wheelchair accessible toilet compartment in the women's restroom at the Darrah Hall has multiple deficiencies. The water closet seat exceeds maximum distance requirements at 18½ inches from the side wall to the centerline of the toilet. The rear grab bar exceeds maximum wall gap requirements at 1¾ inches. The coat hook is installed in the wheelchair accessible toilet compartment at 65½ inches, which exceeds the maximum height requirements for accessibility.

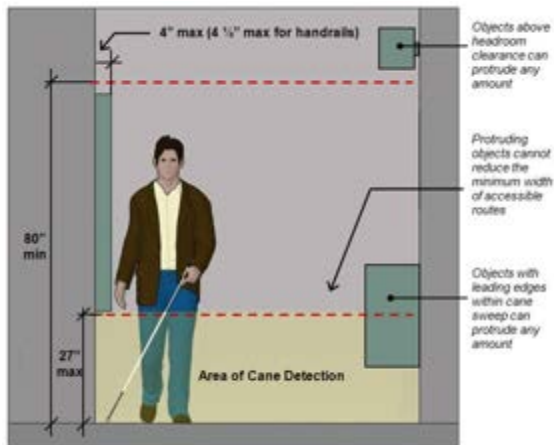
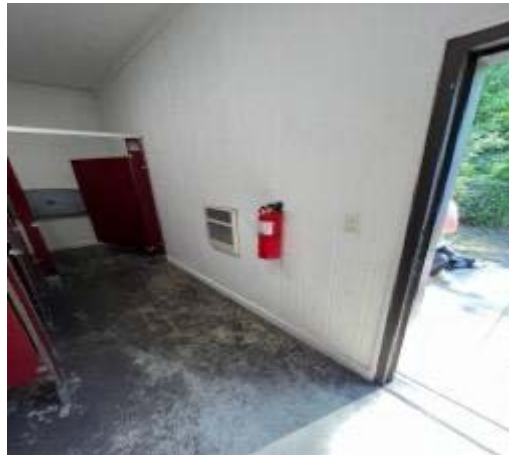
Deficiency: The bottom of the fire extinguisher was measured at 30 inches above the floor and 5½ inches away from the wall, protruding into the path of travel. A protruding object is an accessibility deficiency when the object protrudes more than 4 inches into the path of travel above 27 inches from the finished floor or ground surface.

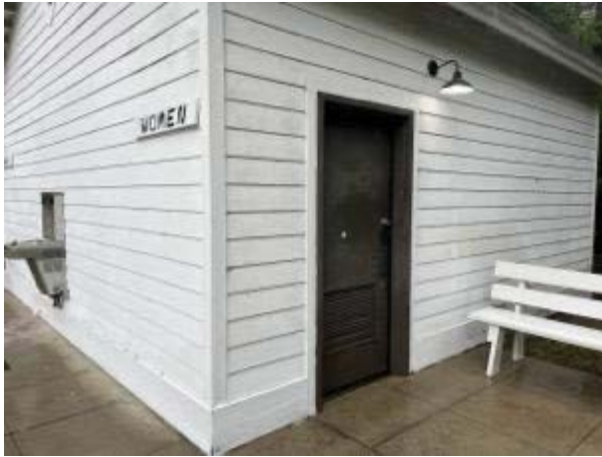
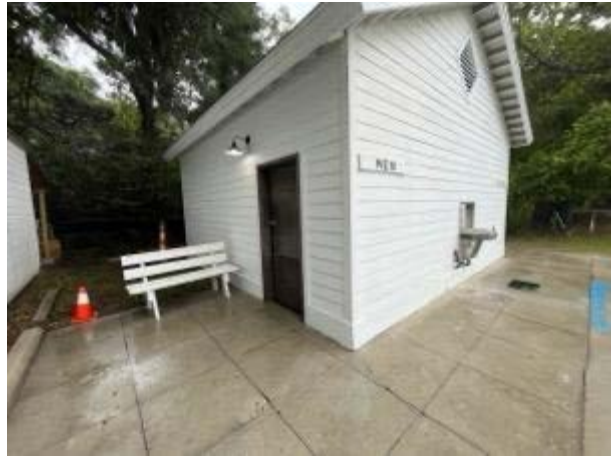
Deficiency: Signage for the men’s and women’s restrooms at the Darrah Hall restroom does not contain the required raised characters, braille, or the International Symbol for Accessibility.

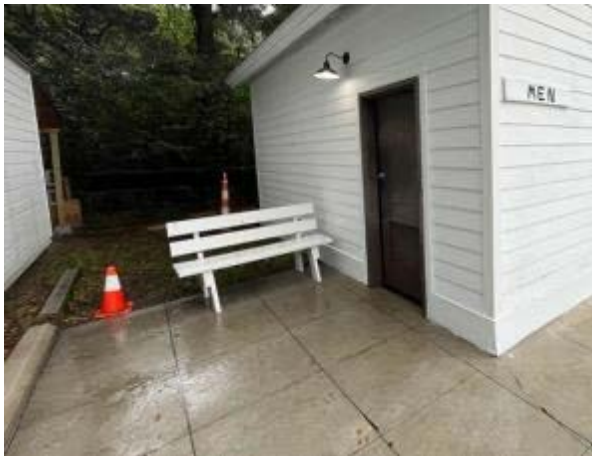
Deficiency: There are two non-fixed plastic benches outside the Darrah Hall restroom building, one on the women's restroom side and one on the men's restroom side. Neither of these benches have an armrest.

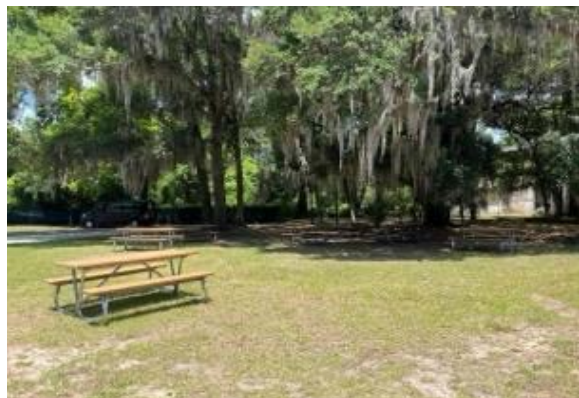
Deficiency: There are 9 non-fixed wood picnic tables provided around Darrah Hall for visitor use. Only one of the tables meets accessibility recommendations, and none of the tables are on an outdoor recreation access route or provide a firm and stable surface around the table.

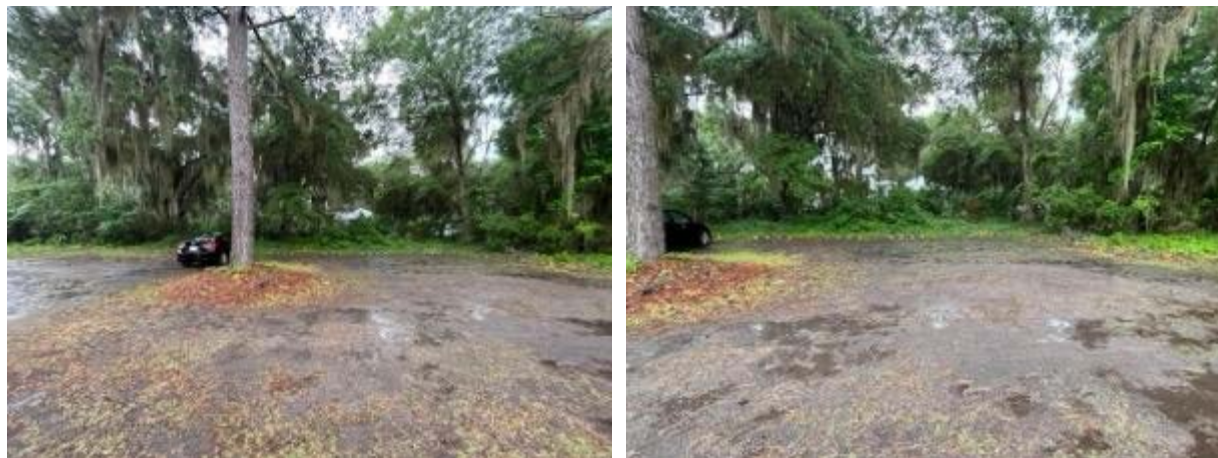
Deficiency: There is no current existing designated accessible parking.

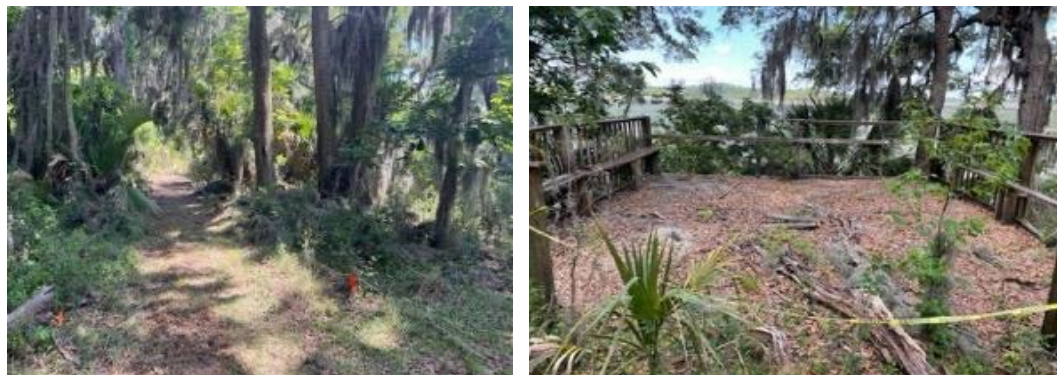
Deficiency: The trail surface is unstable and is not accessible for people with mobility issues. The second issue is that the trailhead sign does not provide required detailed information.

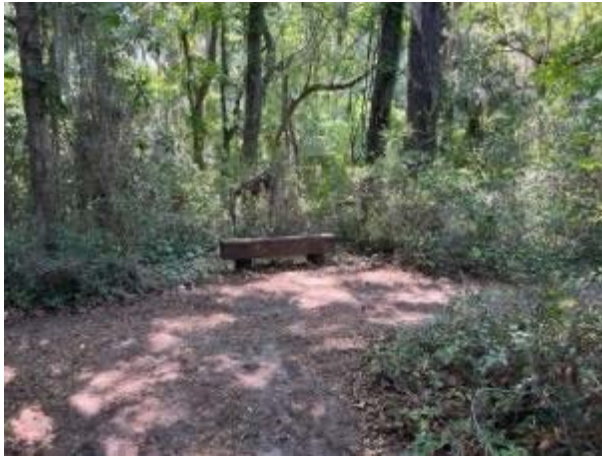
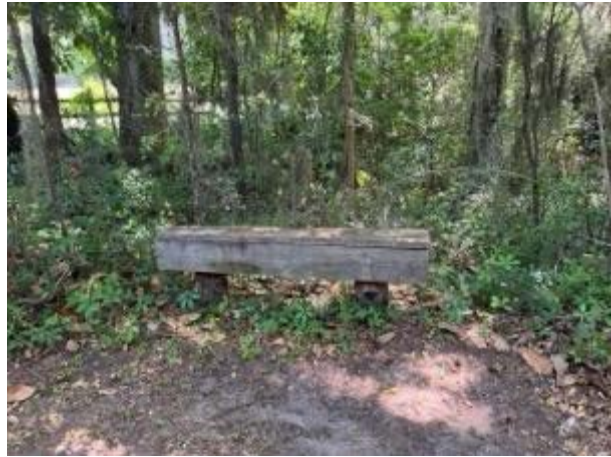
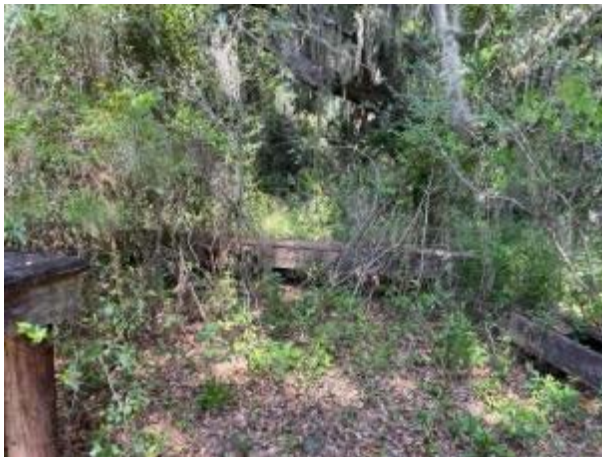
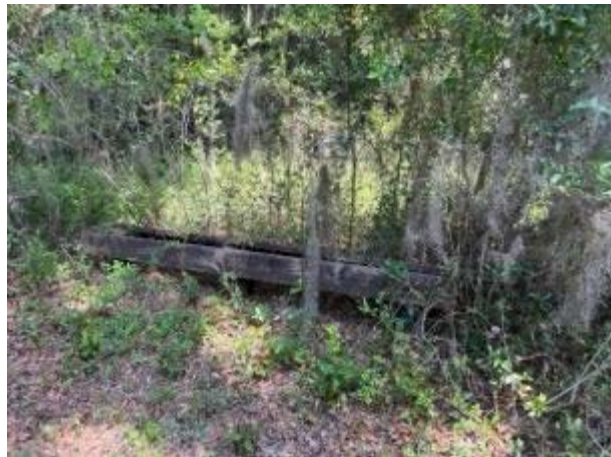
Deficiency: There are four wooden benches along the trail behind Darrah Hall. None of these benches have an armrest or back support.

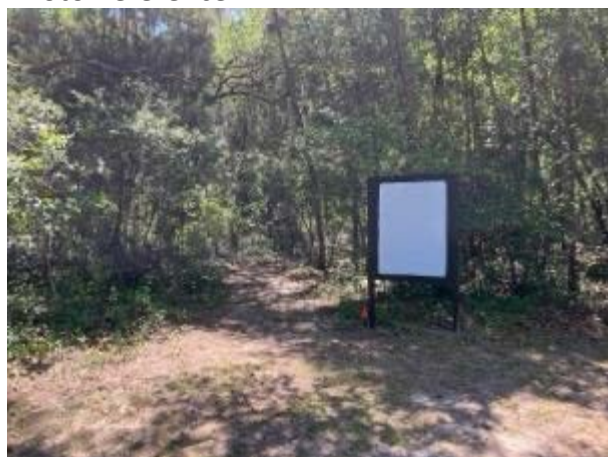
Deficiency: Current trailhead sign does not have required information.

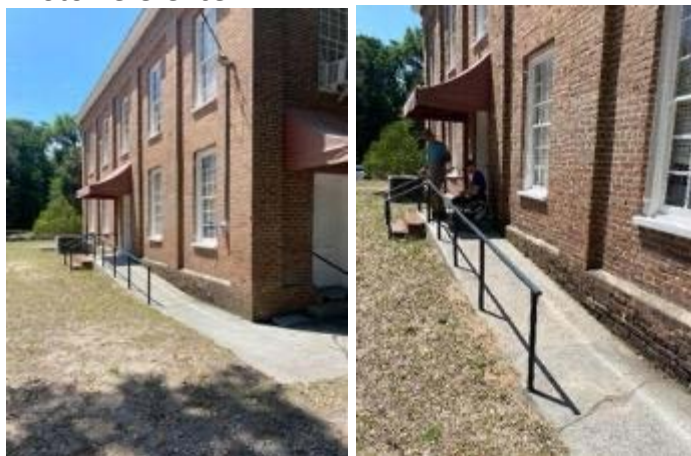
Deficiency: The running slope of the ramp at Brick Baptist Church was measured up to 9.8 percent, which does not meet accessibility guidelines. There is no edge protection on the open (i.e., grass side) side of the ramp. On the building side of the ramp, there is no handrail. There is an exterior rail approximately 33¾ inches tall; however, the height of the handrail is not consistent and does not meet accessibility guidelines.

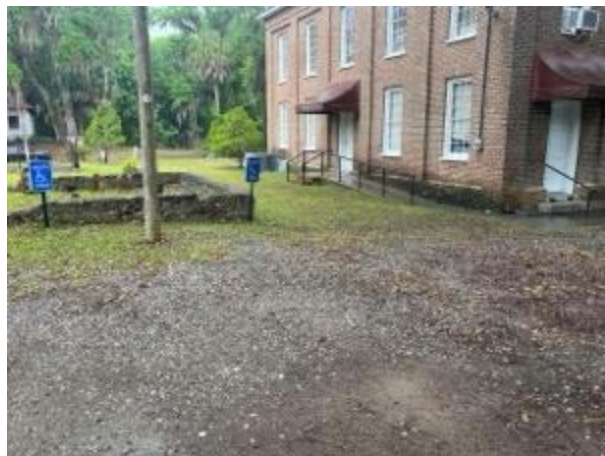
Deficiency: The current existing accessible parking does not meet guidelines; there is no firm and stable surface, no access aisle. The signage was measured at 29½ inches from the ground to the bottom of the sign. There is no van-accessible designation.

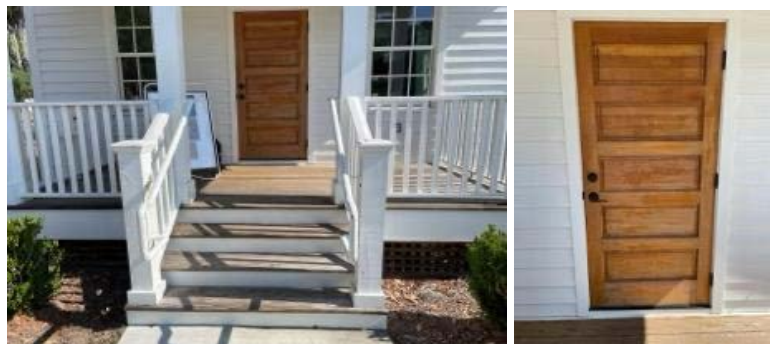
Deficiency: Bottom stair tread is 11½ inches which does not meet the 11 inches accessibility standards. The stair risers are not uniform. The first riser is 5¾ inches, the second and fourth risers are 6¼ inches each, and the third riser is 6 inches. The handrail height measurement is at 33¼ inches on the right-hand side and the left handrail measurement is at 33¼ inches. Concrete on the bottom was poured higher on one side leading to varying riser height for the first step.

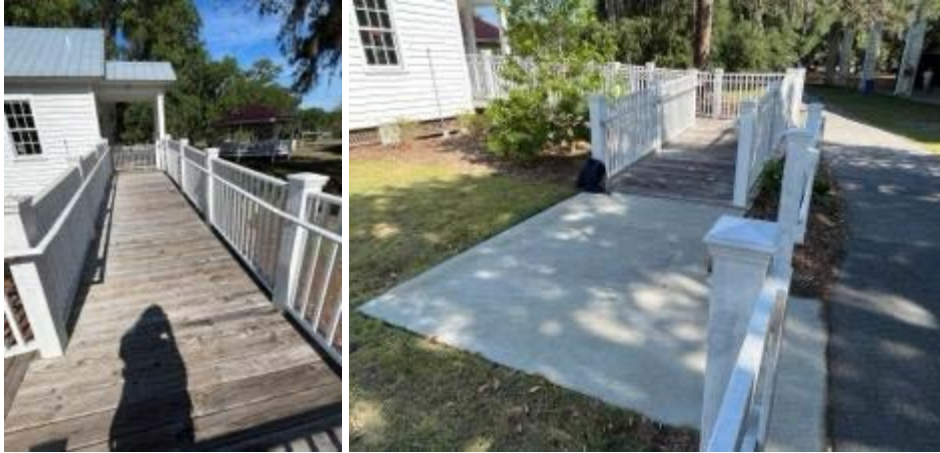
Deficiency: Running slope for the ramp at Pinckney-Porters Chapel exceeds maximum running slope requirements for a ramp with a measurement of up to 10.2 percent before first landing and 8.7 percent after first landing. On both sides of the ramp run, the handrails do not extend past the bottom of the ramp, so they do not meet accessibility standards.

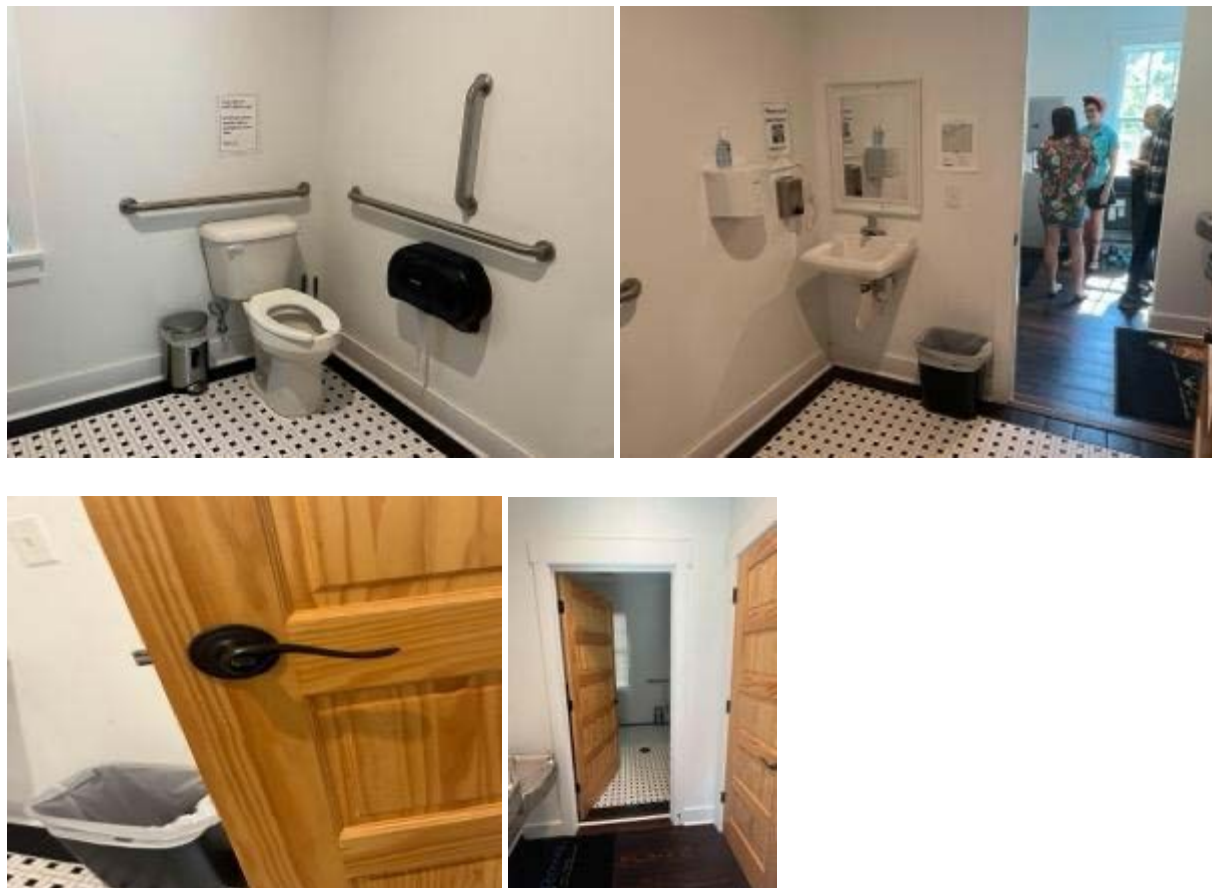
Deficiency: The accessible toilet compartment in the restroom at Pinckney-Porter's Chapel has multiple deficiencies. The rear grab bar exceeds the maximum wall gap requirements at $1\frac{1}{4}$ inches. The side grab bar exceeds the maximum height from the finished floor at $36\frac{1}{2}$ inches. The bathroom lock was not able to be used with a closed fist, therefore it is out of compliance. Signage for the restroom at the Pinckney Porter's Chapel restroom does not contain the required raised characters or braille.

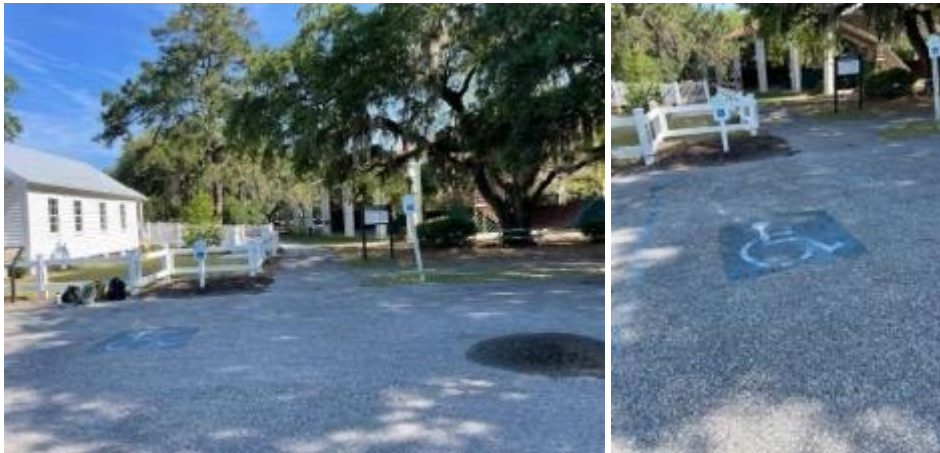
Deficiency: There are two 8-foot accessible parking spaces at Pinckney Church at Camp Saxton, including one access aisle. However, restriping has faded on all parking spots and the access aisle. The accessibility post and sign were measured at 24 $\frac{3}{8}$ inches in height, which does not meet the 60-inch minimum. In addition, one of the two accessible parking spaces needs to be designated as van accessible. The access aisle was measured to be 90 inches wide, which does not meet the 96-inch minimum.

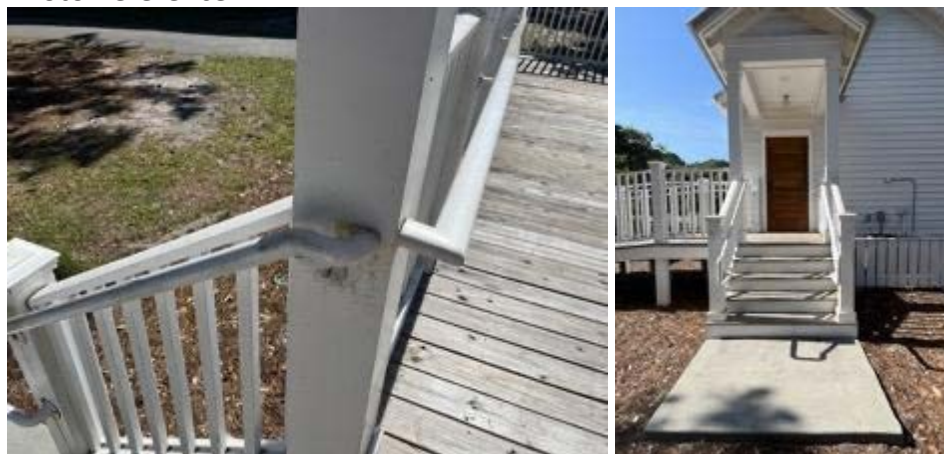
Deficiency: The existing handrail extensions extend 4½ inches at the top of the stairs therefore they do not meet minimum length requirements. The handrail height measured 33 inches from the nosing of the steps and does not meet the minimum requirements for height.

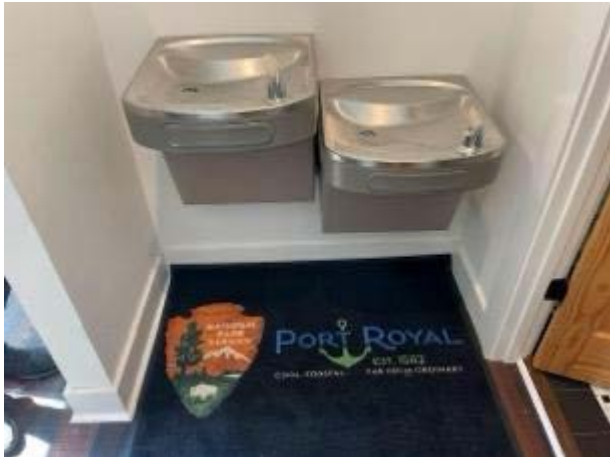
Deficiency: The height of the higher water fountain (standing) was measured at 37 inches from the floor to the waterspout, which does not meet accessibility standards.

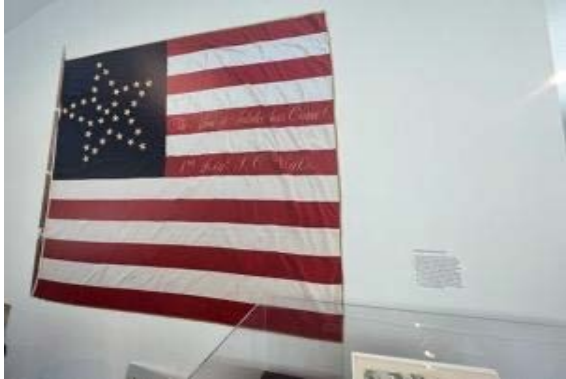
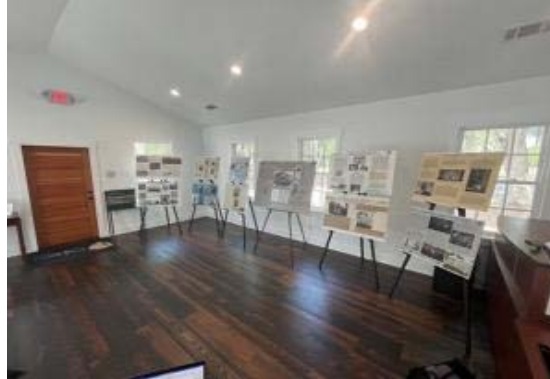
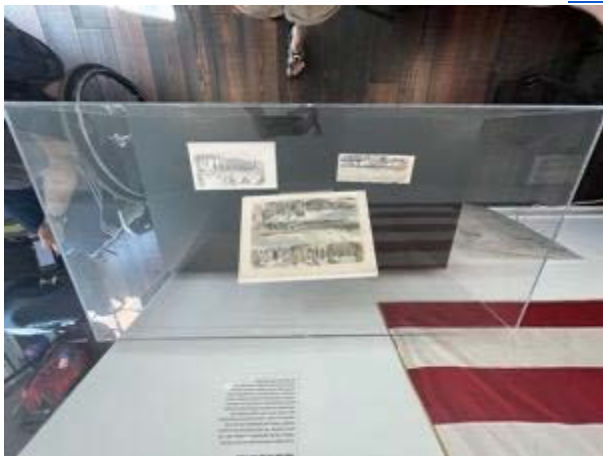
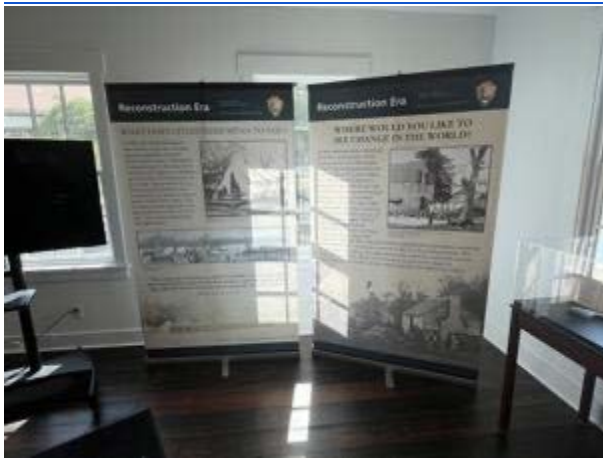
Deficiency: There are multiple deficiencies regarding interpretive exhibits at Camp Saxton. The variety of exhibits is heavily visual and textual with no touchable or interactive experiences. These exhibits include the two glass case exhibit boxes, four semi-permanent standing informational boards, eleven temporary poster boards from University of South Carolina Beaufort, Prince Rivers Replica and sign, and interpretation for flag on the wall. Many of the photos and labels are difficult to read. The text on much of the exhibit content is too small for the viewing distance. There is non-uniform font, size, and insufficient contrast of text on background. There is also insufficient positioning, glare, and lack of audio description, assisted listening, and tactile elements all create barriers to effective communication for persons with low vision, or individuals who are blind or have cognitive impairments.

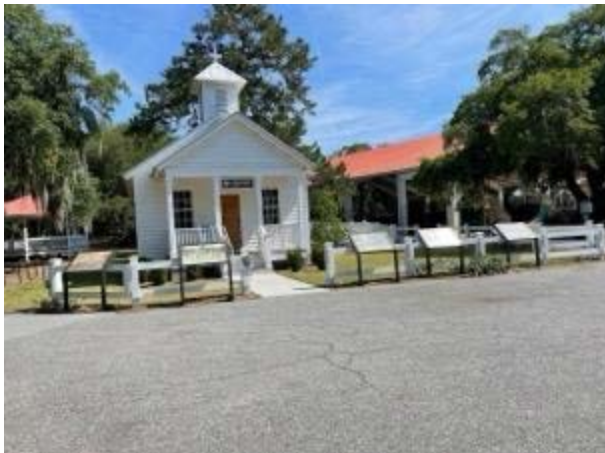
Deficiency: Wayside dimensions are 24½ inches by 40½ inches which meets standards, however, texts are fading. Also, no tactile map for interpretation and audio description for waysides are present.

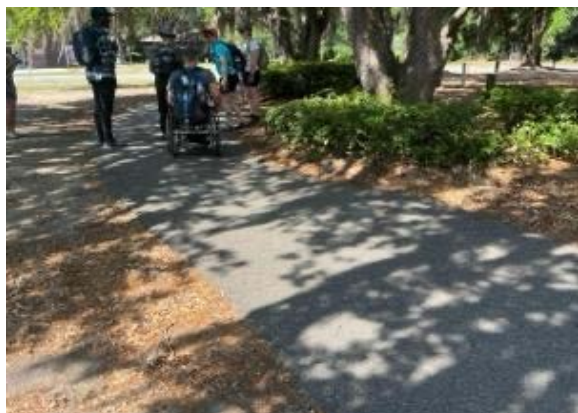
Brief Description: Repair cross slope

Deficiency: There were numerous cross slope deficiencies along the path at Naval Heritage Park, which exceeded the cross slope of 2.08 degrees. All measurements were taken on the pathway starting at Pinckney Porter’s Chapel at the outer loop of the pathway system on the south side of the park.

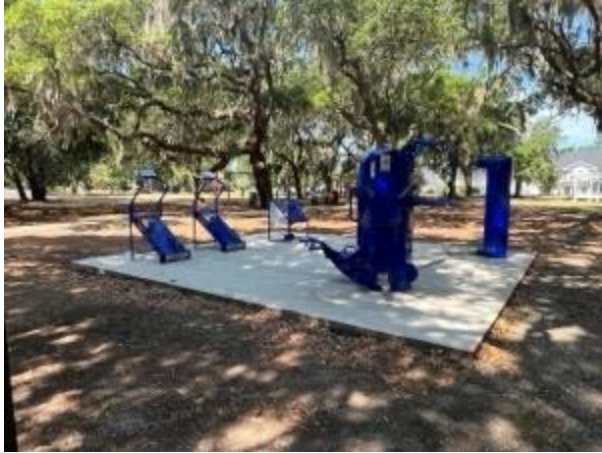
Deficiency: Access to the outdoor gym equipment at the Naval Heritage Park does not contain the required accessible route to the concrete platform.

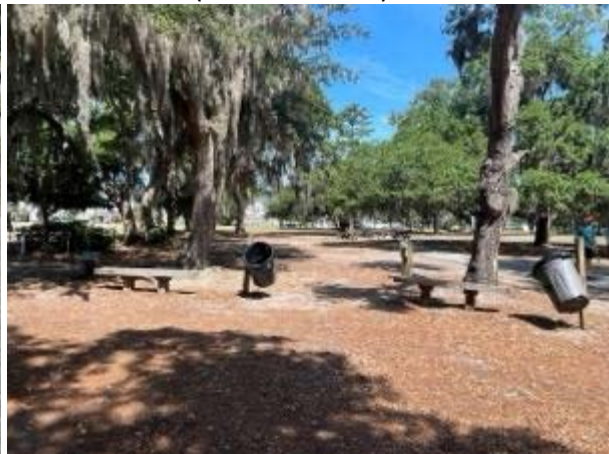
Benches 8-10 (no feet noted):

Deficiency: There are 10 fixed benches provided at the Naval Heritage Park for visitor use. None of the benches meet accessibility recommendations. Benches 6, 7, and 8-10 are not on an accessible route or provide a firm and stable surface around the benches.

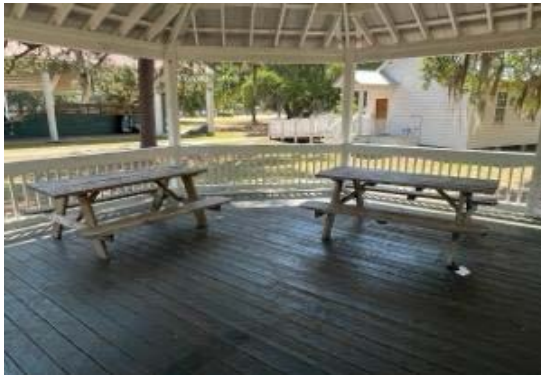
Deficiency: There are 2 non-fixed wood picnic tables provided under the pavilion for visitor use. Neither of the tables meet accessibility standards.

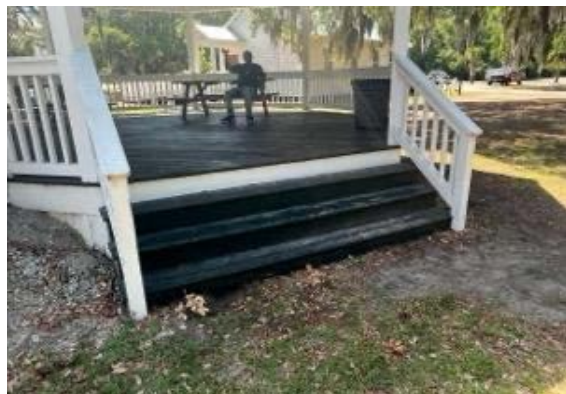
Deficiency: The riser height of the pavilion stairs at Naval Heritage Park are not uniform. The first riser height measures at 6 inches, the second and third riser measure at 7¼ inches, and the fourth riser measures at 7½ inches. There is no hand railing on either side.

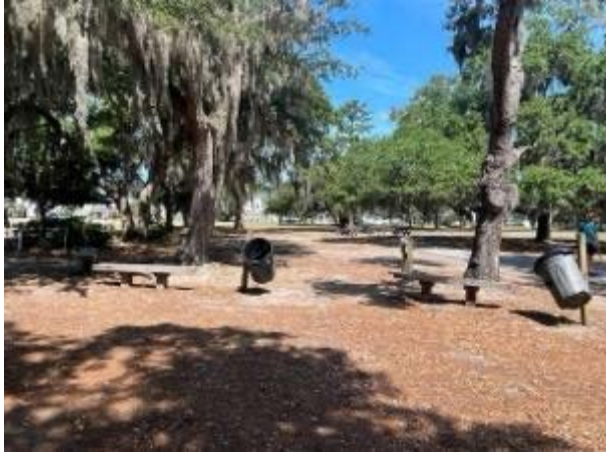
Deficiency: Two trash receptacles are not on an accessible route.

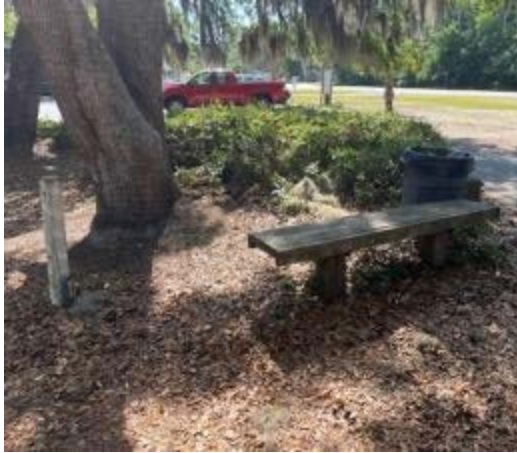
Deficiency: The water hydrant measured at 83 feet along the Naval Heritage Park outside of the Pinckney Church at Camp Saxton was not on an accessible route and was measured to be 11 feet 1 inch from the walking path.

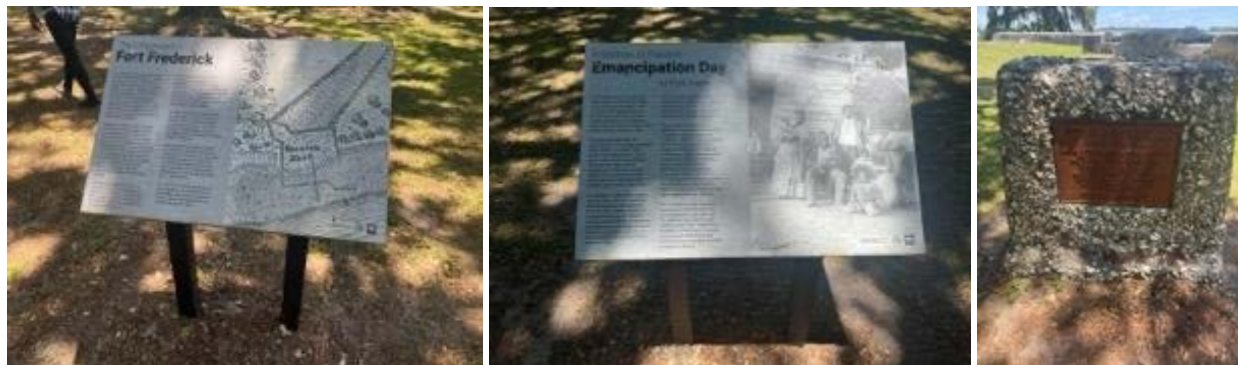
Deficiency: There is not an accessible route to the five existing waysides, Fort Frederick tabby sign, and tide water level distance point at Fort Frederick.

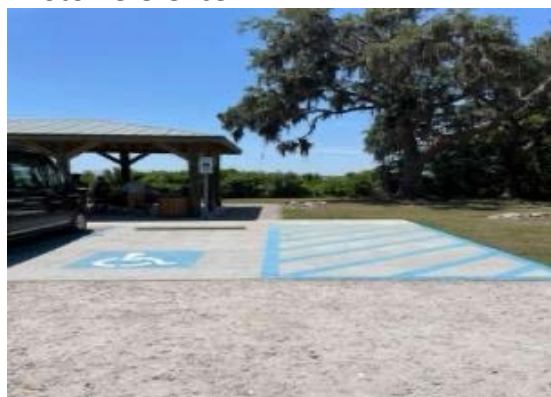
Deficiency: The cross slope in the access aisle located at Fort Frederick is measured up to 2.6 percent which does not meet accessibility slope requirements.

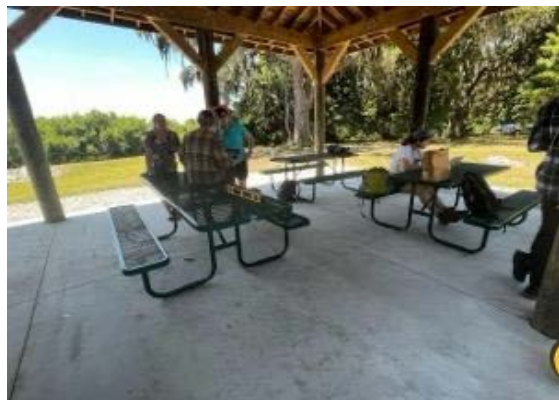
Deficiency: There are ten fixed metal picnic tables, nine under the pavilion and one down a paved route, only one of the tables meets accessibility recommendations.

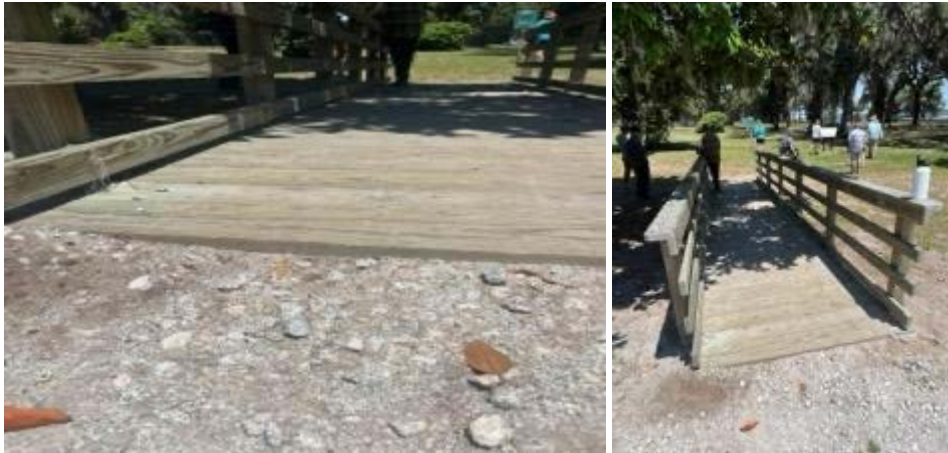
Deficiency: The entry to the walkway is 1¼ inches above grade and the exit end is 3 inches above the grade.

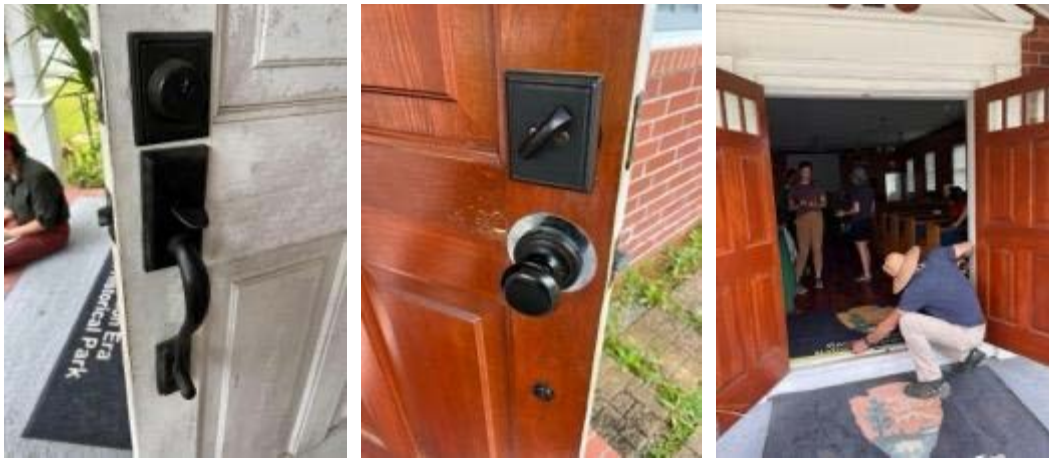
Deficiency: Exterior entry door operable side opening clear width measurement is 31 inches and does not meet minimum requirements for clear width. Interior and exterior door handles/knobs are not operable with a closed fist.
