Reconstruction Era National Historical Park Accessibility Assessment

Summary Report

Gary Everhardt Park Break Program

July 2023

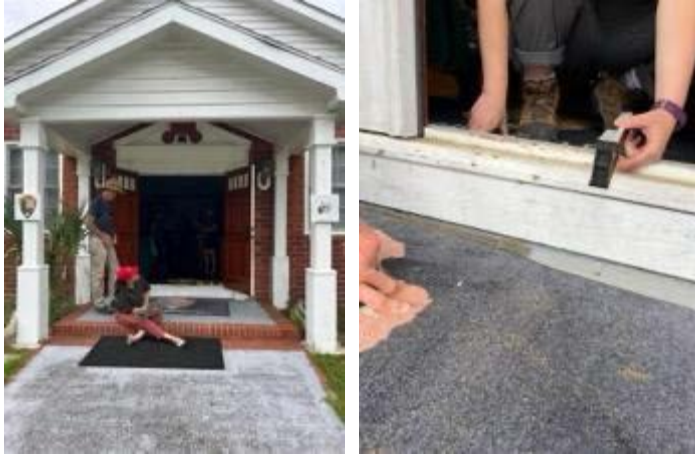
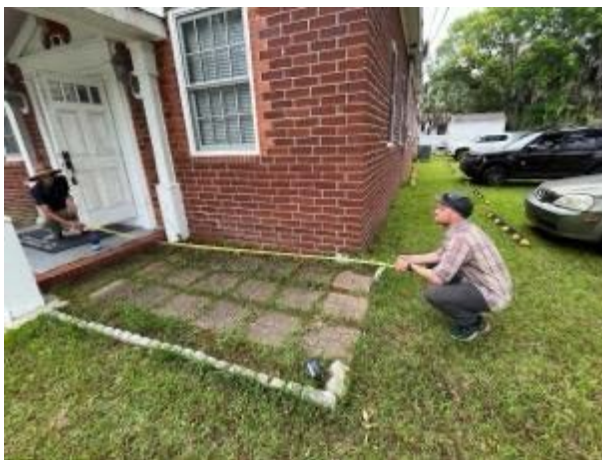
Deficiency: There is no accessible entry into the Learning Center. The step into the threshold is 8½ inches and the maximum rise is 7 inches. The front porch at the Learning Center measures 10 feet ¼ inch by 6 feet 1 inch and is currently 5 inches above grade. Currently the perimeter of the front porch is unprotected and does not provide edge protection.

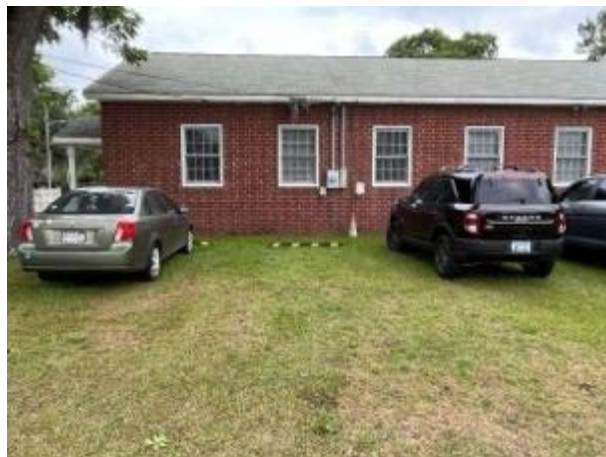
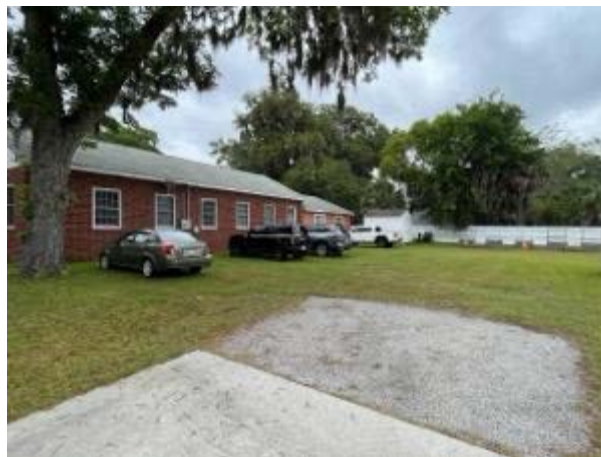
Deficiency: There is no current existing designated accessible parking.

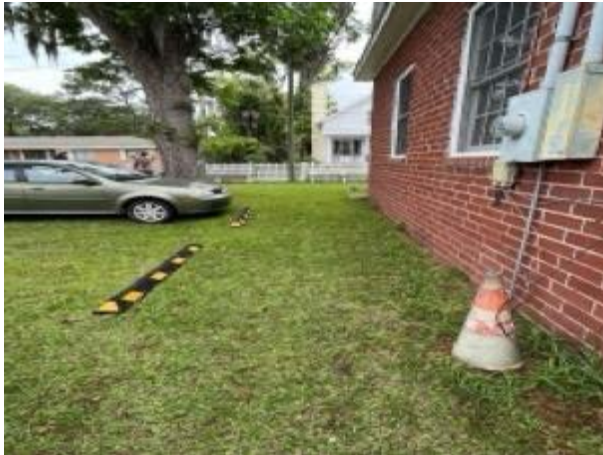
Deficiency: There is no accessible route from the proposed accessible parking to the existing pedestrian-accessible route at the Learning Center.

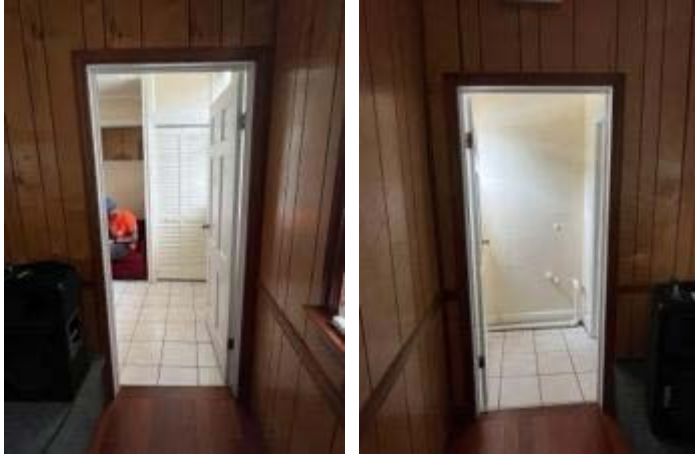
Deficiency: The first north doorway is 31 inches wide and the second north doorway (which has no door) measures 27 inches wide. The south doorway is 31 inches wide.

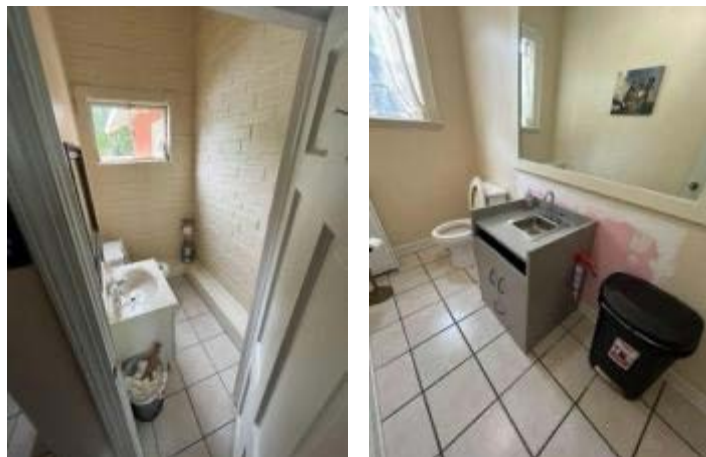
Deficiency: There are two restrooms in the Learning Center building. Neither of the two restrooms are designated as accessible and neither meet accessibility requirements. Where multiple single-user toilet rooms are clustered at a single location, at least one but no more than 50 percent of the single user toilet rooms shall be required to be accessible. The door for the bathroom closest to the stage is measured at 27½ inches, which does not meet accessibility requirements.

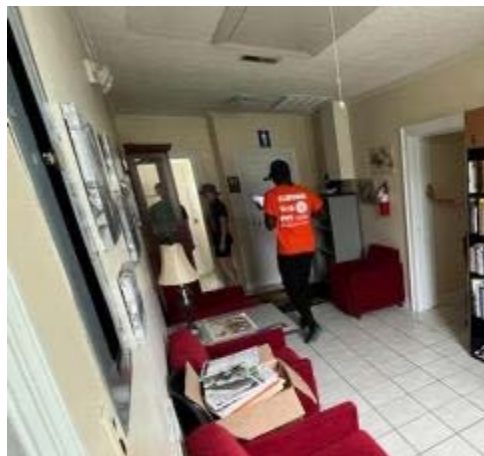
Deficiency: At the backstage of the Learning Center, the fire extinguisher is as high as 54 $\frac{3}{8}$ inches and the other fire extinguisher inside the Learning Center in the lobby/common area is 59 inches high. A protruding object is an accessibility deficiency when the object protrudes more than 4 inches into the path of travel above 27 inches from the finished floor or ground surface. The fire extinguishers are also outside of accessibility reach range requirements.

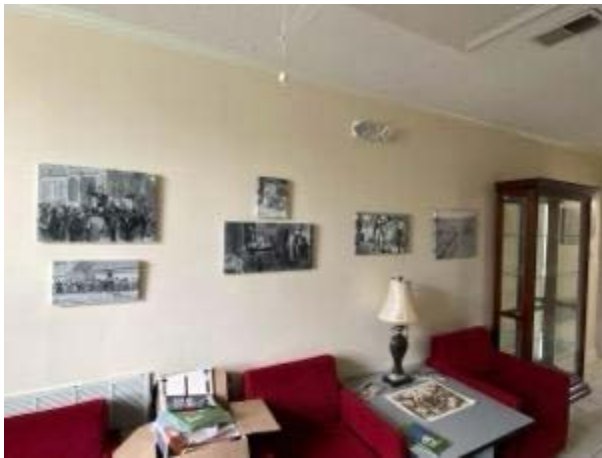
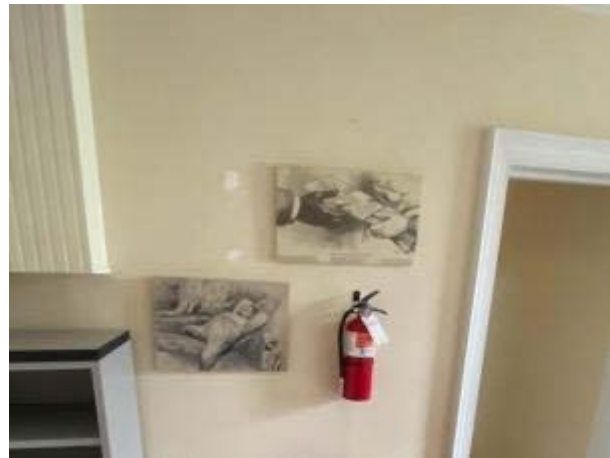
Deficiency: Wall canvases in the Learning Center need audio descriptions; pamphlets and posters in the hallway behind the stage need alternate format. The existing visual elements and

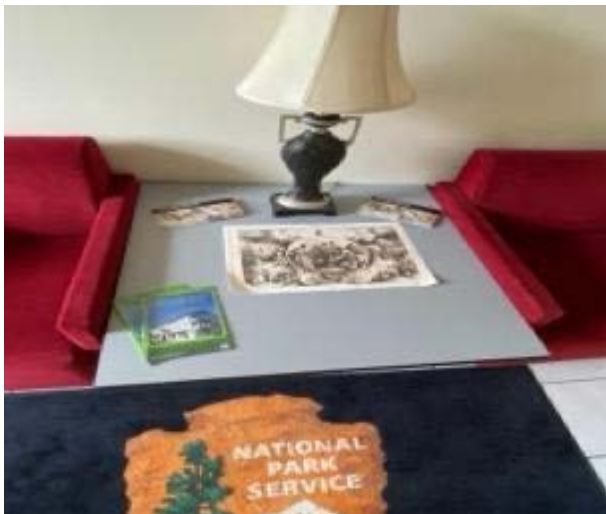
Deficiency: The printed NPS publications, including the primary site brochure for the Learning Center and interpretive handouts, are not provided in alternate formats.
