Reconstruction Era National Historical Park Accessibility Assessment

Summary Report

Gary Everhardt Park Break Program

July 2023

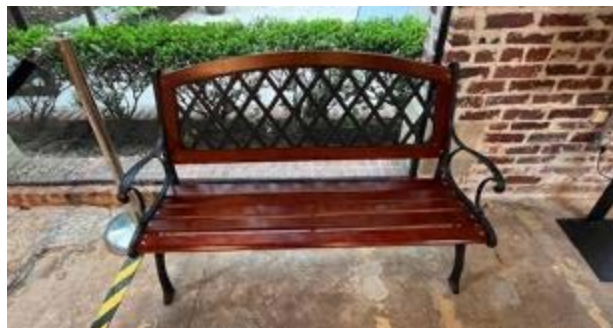
Brief Description: Provide accessible bench

Deficiency: There is one bench in the main visitor center area. This bench is not fixed. The bench height from floor to sitting area is 16¼ inches. The bench depth is 15½ inches. Due to the height and depth measurement results, this bench does not meet accessibility standards.

Recommendations: In keeping with best practices for Universal Design, the recommendation is that when replacing the existing bench, provide a fully accessible bench. Factors to include are back support and at least one armrest. The back support shall be 2½ inches maximum from the rear edge of the seat measured horizontally. The seat height shall measure between 17 inches

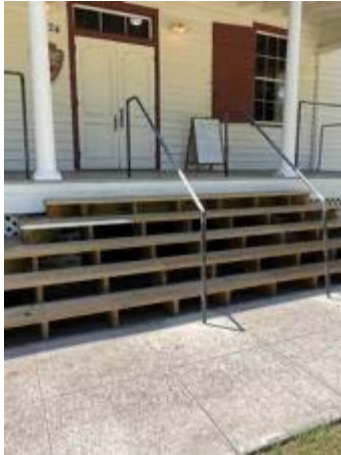
Brief Description: Close stair risers, add compliant handrail

Deficiency: Stairs with open risers do not meet accessibility requirements. All five stairs have open risers. The handrail on the front porch is 9¼ inches from nosing to the end of edge of the handrail.

Recommendations: Close in open risers at the front porch. The handrail gripping surface shall be continuous along the length of the stair flight and shall not be obstructed along the top or sides. The bottom of the handrail gripping surface shall not be obstructed for more than 20 percent of the total length of the handrail. Handrail gripping surfaces with a circular cross section shall have an outside diameter of 1¼ inches minimum and 2 inches maximum. Handrail gripping surfaces with a non-circular cross section shall have a perimeter dimension of 4 inches minimum and 6¼ inches maximum, and a cross-section dimension of 2¼ inches maximum. At the top of the stair flight, the handrails shall extend horizontally above the landing for 12 inches minimum above the first riser nosing. At the bottom of a stair flight, the handrails shall extend at the slope of the stair flight for a horizontal distance at least equal to one tread depth beyond the last riser nosing. Extensions shall return to a wall, guard, or the landing surface.

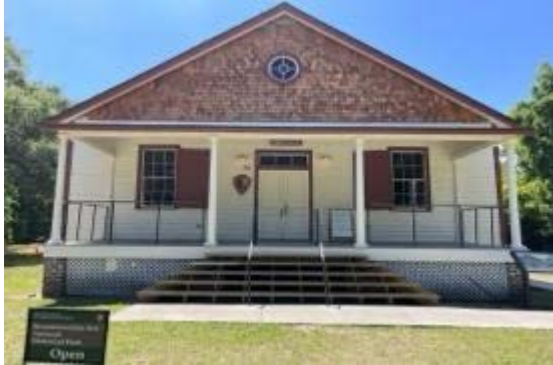
Brief Description: Add front porch edge protection

Deficiency: The perimeter railing system of the front porch at Darrah Hall is unprotected and does not provide edge protection (46 feet 9 inches).

Recommendations: Install additional brass material to cover the openings on rails at the front porch of Darrah Hall. This will reduce the security risks. Clearance between handrail gripping surfaces and adjacent surfaces shall be 1½ inches minimum. The handrail gripping surface shall be continuous along its length and shall not be obstructed along its top or sides. The bottom of the handrail gripping surface shall not be obstructed for more than 20 percent of its length. Handrail gripping surfaces with a non-circular cross section shall have a perimeter dimension of 4 inches minimum and 6¼ inches maximum, and a cross-section dimension of 2¼ inches maximum. Handrail gripping surfaces with a circular cross section shall have an outside diameter of 1¼ inches minimum and 2 inches maximum.

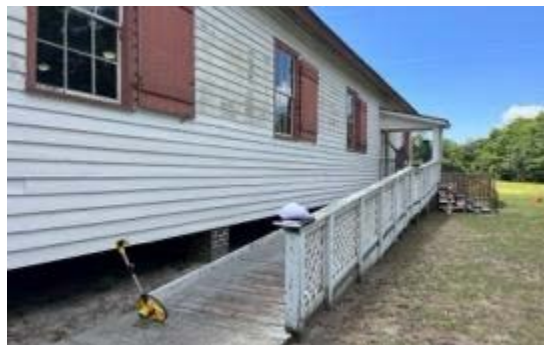
Brief Description: Ramp and add handrails

Deficiency: On the north side of Darrah Hall, there is a ramp 42 feet 7 inches long. The slope of the ramp varied with the highest measurement of 10.6 percent running slope, which does not meet accessibility requirements for a ramp. Additionally, neither side of the ramp has the required handrails.

Recommendations: Remove and replace the existing wood ramp. The slope needs to be corrected so that the maximum slope is 8.33 percent or less. The running slope of the new ramp shall not exceed 8.33 percent, and the cross slope shall not exceed 2.08 percent. Provide a minimum 5 feet by 5 feet landing at the top and bottom of the ramp run. The rise for any ramp run shall be 30 inches maximum. Intermediate landings located along a ramp run shall be 60 inches deep minimum and at least as wide as the ramp. The slope of a landing shall not exceed 2.08 percent. The clear width of the ramp shall be 36 inches minimum measured between the handrails.

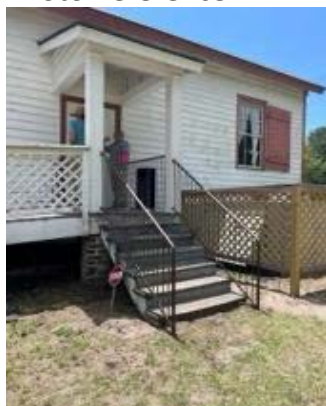
Brief Description: Add compliant handrails, repair riser height

Deficiency: Both hand railings at the bottom of the stairs extended 8¼ inches beyond the last riser nosing with a tread of 11½ inches. The hand railing on the top of the stairs does not extend to 12 inches and is not continuous on both sides. The bottom riser was not uniform in height with other stairs.

Recommendations: At the top of a stair flight, handrails on both sides shall extend horizontally above the landing for 12 inches minimum beginning directly above the first riser nosing. Move the railing inward toward the center of stairs and wrap the top of the railing around the top posts. At the bottom of a stair flight, handrails shall extend at the slope of the stair flight for a horizontal distance at least equal to one tread depth of 11½ inches beyond the last riser nosing. Extension shall return to the landing surface. All steps on a flight of stairs shall have uniform riser heights and uniform tread depths. General maintenance to clear the area of the bottom riser height of 6¼ inches.

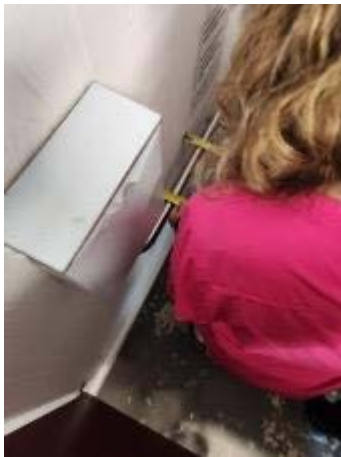
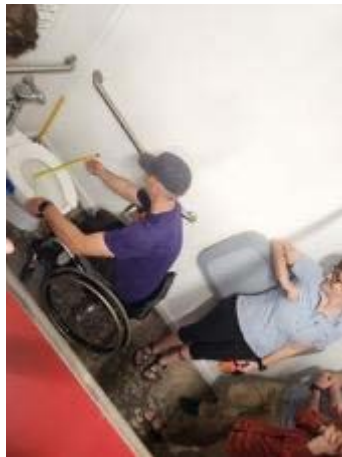
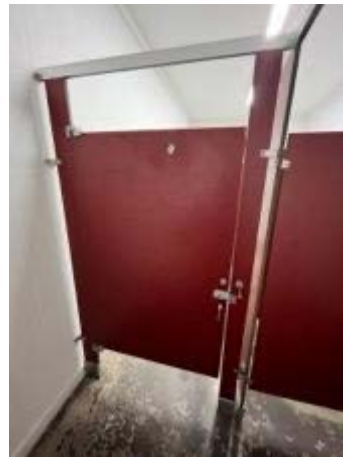
Brief Description: Women's wheelchair accessible toilet compartment

Deficiency: The wheelchair accessible toilet compartment in the women's restroom at the Darrah Hall has multiple deficiencies. The water closet seat exceeds maximum distance requirements at 18½ inches from the side wall to the centerline of the toilet. The rear grab bar exceeds maximum wall gap requirements at 1¾ inches. The coat hook is installed in the wheelchair accessible toilet compartment at 65½ inches, which exceeds the maximum height requirements for accessibility.

Recommendations: Remove and reinstall the wall mounted water closet in the women's restroom wheelchair accessible toilet compartment so that the centerline of the water closet is 16 inches minimum and 18 inches maximum from the side wall. Also ensure that the seat height remains 17 inches minimum and 19 inches maximum above the finished floor. Ensure when installing the rear grab bar, that the gap between the wall and the bar is 1½ inches. Ensure both the side and rear grab bars in the stall have the top of the gripping surface is 33 inches minimum and 36 inches maximum above the finish floor. Ensure that when reinstalling the side grab bar, one end measures 12 inches maximum from the rear wall and the other is 54 inches minimum from the rear wall. The rear bar shall extend from the centerline of the toilet 12 inches minimum on one side and 24 inches minimum on the other side. Remove and reinstall the coat hook so that the high forward reach to the top of the hook is 48 inches maximum above the finish floor.

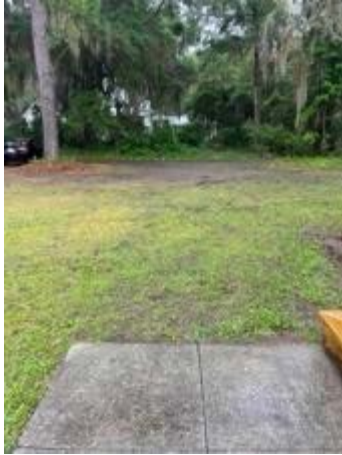
Brief Description: Install accessible route from parking

Deficiency: There is no accessible route from the proposed accessible parking to the existing pedestrian accessible route in front of Darrah Hall.

Recommendations: Park management shall install an accessible route from the proposed access aisle in the designated parking area to the existing pedestrian accessible route in front of Darrah Hall. Grade the affected area and resurface with in-kind materials so that the cross slope of the route does not exceed 2.08 percent and the running does not exceed 5 percent. The accessible route from the proposed accessible parking would be 51 feet 11 inches long by 60 inches wide from the back of the proposed access aisle adjoining the proposed accessible parking to the existing front sidewalk. The clear width of walking surfaces shall be 36 inches minimum.

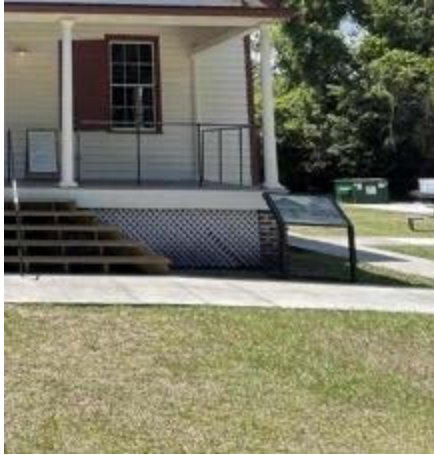
Brief Description: Move existing wayside

Deficiency: The height of the wayside outside of Darrah Hall is 31½ inches, which does not meet the minimum requirement of 32 inches.

Recommendations: Remove the existing movable wayside outside of Darrah Hall. Find a stable surface that meets the recommended height of waysides at 32 inches from the bottom of the wayside frame to the ground surface.

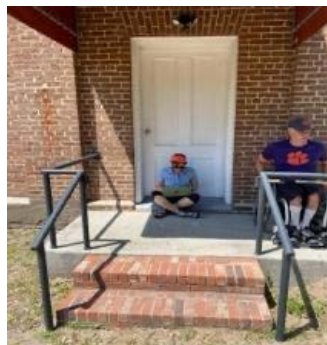
Brief Description: Steps and handrail

Deficiency: The stair flight on the south side of the Brick Baptist Church that leads to the top of the ramp and the south side entrance includes two risers, one that measures 6 $\frac{1}{8}$ inches and a second that measures 4 inches. This does not meet the minimum requirements for accessibility. The existing handrail extensions do not extend at the top and bottom landings; therefore, they do not meet minimum length requirements. The handrail height measured 27 $\frac{1}{2}$ inches from the nosing of the steps and does not meet the minimum requirements for height.

Recommendations: Repair steps to a uniform riser height between 4 inches and 7 inches. All steps on a flight must have uniform riser heights within a range of 4 inches to 7 inches and uniform tread depths that are a minimum of 11 inches. Open risers are prohibited. Remove the existing handrails along the stairs leading to the south entrance. Each handrail shall include the required 12-inch extensions at the top and bottom landings and the length required to return the rails to the cement landing surface. The top gripping surface of handrails shall be 34 inches minimum and 38 inches maximum measured vertically above the stair nosing. The handrail gripping surface shall be continuous along its length and shall not be obstructed along its top or sides. The bottom of the handrail gripping surface shall not be obstructed for more than 20 percent of its length. Handrail gripping surfaces with a non-circular cross-section shall have a perimeter dimension of 4 inches minimum and 6 $\frac{1}{4}$ inches maximum and a cross-section dimension of 2 $\frac{1}{4}$ inches maximum. Handrail gripping surfaces with a circular cross-section shall have an outside diameter of 1 $\frac{1}{4}$ inches minimum and 2 inches maximum.

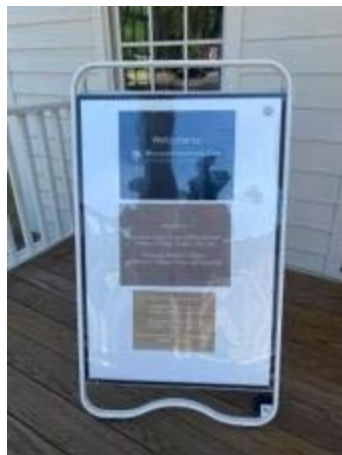
Brief Description: Provide accessible text

Deficiency: The text size on the front temporary sign is small, text and background coloring need contrast.

Recommendations: Park management shall work with design services to investigate a comprehensive redesign of interpretive exhibits and panels throughout the Sculptors Studio. When panels and/or exhibits are replaced, ensure that the information is presented in a way that is accessible to the widest range of visitors. Things to consider in interpretive design include the use of sans serif or simple serif fonts (i.e., as opposed to serif fonts), minimal use of italics, contrast between text and background of 70 to 95 percent, and the incorporation of audio and tactile elements. Text should not appear over images or in shadow as the stylistic presentation of information can interfere with readability. Additionally, tactile experiences are essential to people with visual impairments and may greatly assist in conveying the interpretive message to many people with cognitive disabilities. Select tactile objects and models that provide a coherent explanation of the exhibition topic and provide an equal opportunity to understand what is displayed in exhibit cases or behind barriers. Touchable models or reproductions of items central to the interpretive story shall be considered. Include these tactile exhibits in the audio described tour recommended in a separate work order.

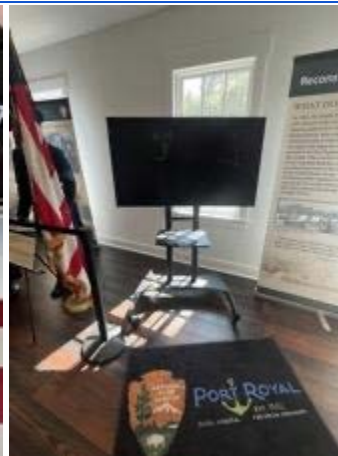
Brief Description: Provide interactive experiences

Deficiency: There are multiple deficiencies regarding interpretive exhibits at Camp Saxton. The variety of exhibits is heavily visual and textual with no touchable or interactive experiences. These exhibits include the two glass case exhibit boxes, four semi-permanent standing informational boards, eleven temporary poster boards from University of South Carolina Beaufort, Prince Rivers Replica and sign, and interpretation for flag on the wall. Many of the photos and labels are difficult to read. The text on much of the exhibit content is too small for the viewing distance. There is non-uniform font, size, and insufficient contrast of text on background. There is also insufficient positioning, glare, and lack of audio description, assisted listening, and tactile elements all create barriers to effective communication for persons with low vision, or individuals who are blind or have cognitive impairments.

Recommendations: Park management shall work with design services to investigate a comprehensive redesign of interpretive exhibits and panels throughout Camp Saxton. When panels and/or exhibits are replaced, ensure that the information is presented in a way that is accessible to the widest range of visitors. Things to consider in interpretive design include the use of sans serif or simple serif fonts (as opposed to non-uniform text fonts and size), minimal use of italics, contrast between text and background of 70 percent to 95 percent, and the incorporation of audio and tactile elements. Text should not appear over images or in shadow as the stylistic presentation of information can interfere with readability. Additionally, tactile experiences are essential to people with visual impairments and may greatly assist in conveying the interpretive message to many people with cognitive disabilities. Select tactile objects and models that provide a coherent explanation of the exhibition topic and provide an equal opportunity to understand what is displayed in exhibit cases or behind barriers. Touchable models or reproductions of artifacts, and other items central to the interpretive story shall be considered while the park does provide a period jacket for visitors to try on. Include these tactile exhibits in the audio described tour recommended in a separate work order.

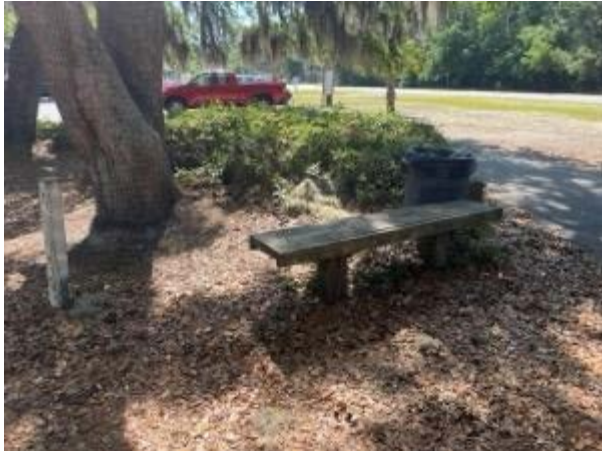
Bench 1 (83 feet):

Deficiency: There are 10 fixed benches provided at the Naval Heritage Park for visitor use. None of the benches meet accessibility recommendations. Benches 6, 7, and 8-10 are not on an accessible route or provide a firm and stable surface around the benches.

Recommendations: In keeping with best practices for Universal Design, the recommendation is that when replacing the existing benches, provide 100 percent accessible benches within a given area. Until the park decides to remove existing benches, the recommendation is to add two new accessible benches and install them along the Naval Heritage Park Path. Accessible

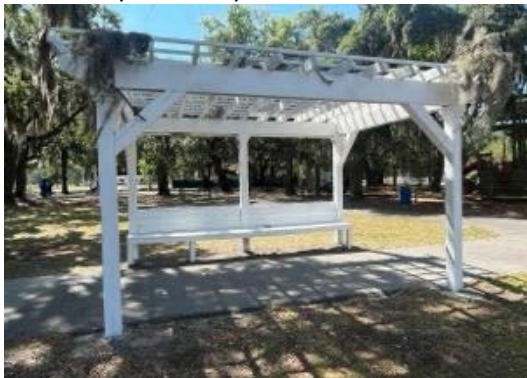
Bench 3 (707 feet):

Deficiency: There are 3 fixed benches provided at the Naval Heritage Park under a pergola for visitor use. None of the benches meet accessibility recommendations.

For Bench 3, the seat height is 21 inches, which does not meet accessibility standards. Seat depth is 16½ inches, which does not meet accessibility standards. The bench does not have at least one armrest.

Recommendations: Given the fact that the bench is underneath the pergola, the recommendation is to make the necessary adjustments to meet accessibility standards for one of the existing benches to meet accessibility standards. Accessible benches shall have back support, at least one armrest and a seat height between 17 inches and 19 inches above the ground. Benches shall have a seat depth between 20 inches deep minimum and 24 inches deep maximum. Accessible benches shall be installed on an accessible route. Ensure that clear ground space measuring 36 inches by 48 inches minimum is positioned near the bench, but not overlapping the path of travel, for companion seating. The slope of the clear ground space shall not exceed 2.08 percent in any direction.

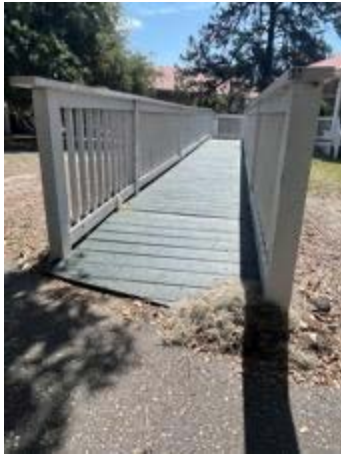
Brief Description: Reduce running slope of ramp to pavilion

Deficiency: The running slope for the ramp at the Naval Heritage Park ramp exceeds maximum running slope requirements for a ramp with a measurement of up to 10.6 percent. The entrance from the path to the ramp has a vertical change in level of 1 inch, which does not meet requirements. Due to the recorded running slope in this location, each section is considered a ramp; however, neither route includes the required handrails.

Recommendations: Running slope greater than 8.33 percent is not permitted on a ramp. Ramp handrails shall extend horizontally above the landing for 12 inches minimum beyond the top and bottom of ramp runs. Extensions shall return to a wall, guard, or the landing surface, or shall be continuous to the handrail of an adjacent ramp run. Ramp needs to be adjusted so change in level is reduced from 1 inch to ¼ inch. Anything above ¼ inch needs to be beveled. Purchase and install 2 compliant handrails onto each side of the ramp. Handrails are required on both sides of a ramp that serve as part of an accessible route. Each handrail shall be a total length of approximately 92 linear feet. This length includes the length of the ramp run and the required 12-inch top and bottom extensions. The top gripping surface of handrails shall be 34 inches minimum and 38 inches maximum vertically above the ramp surface. The handrail gripping surfaces shall be continuous along their length and shall not be obstructed along their tops or sides. The bottom of the handrail gripping surfaces shall not be obstructed for more than 20 percent of their length. Handrail gripping surfaces with a circular cross section shall have an outside diameter of 1¼ inches minimum and 2 inches maximum. Handrail gripping surfaces with a non-circular cross section shall have a perimeter dimension of 4 inches

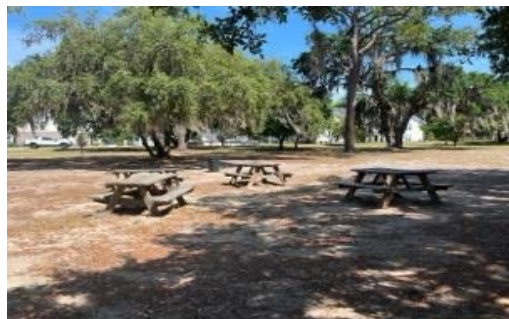
Brief Description: Accessible route to picnic tables

Deficiency: There are four non-fixed wood picnic tables provided at Heritage Park for visitor use. None of the tables meets accessibility recommendations, and none of the tables are on an outdoor recreation access route or provide a firm and stable surface around the table.

Recommendations: Provide a minimum of two accessible picnic units at Heritage Park. Where picnic facilities contain more than two picnic units, at least 20 percent but not less than two of the units shall be accessible. Disperse the two new accessible picnic units accordingly to provide choices of picnic units comparable to, and integrated with, those available to others (i.e., near shade, etc.). Pave a trail spur to each accessible unit and provide solid surface under and around each accessible unit.

The recommendation includes the purchase of two accessible rectangle picnic tables with an overhang that provides toe clearance of 9 inches above the ground surface for a minimum depth of 17 inches and knee clearance of 27 inches above the ground surface for a minimum depth of 8 inches at the wheelchair space. Ensure table braces, bolts, etc. do not impede the required toe and knee clearance. Ensure the new tables provide at least one wheelchair space for each 24 linear feet of usable table surface perimeter. Wheelchair spaces shall be 30 inches minimum by 48 inches minimum positioned for a forward approach to the table. The accessible tables shall be located on an outdoor recreation access route and shall provide 36 inches minimum clear space along all usable sides of the table measured from the back edge of the benches.

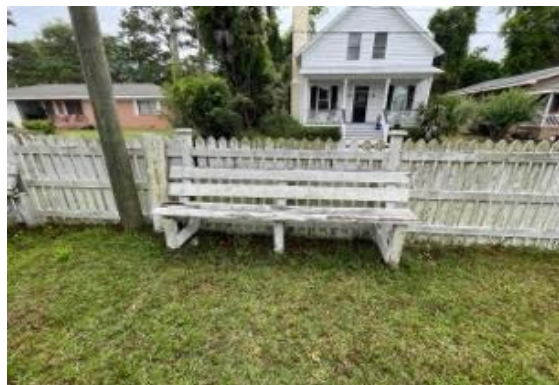
Smaller bench

Deficiency: There are two benches outside of the Learning Center. Neither of the benches have arm rests. The top of the seat surface of the smaller bench measures at a height of 19 ¼ and 12 inches in depth and the top of the seat surface of the larger bench measures at a height of 19½ inches and 11 inches in depth, which does not meet accessibility requirements. Neither bench is on an accessible surface.

Brief Description: Add accessible benches

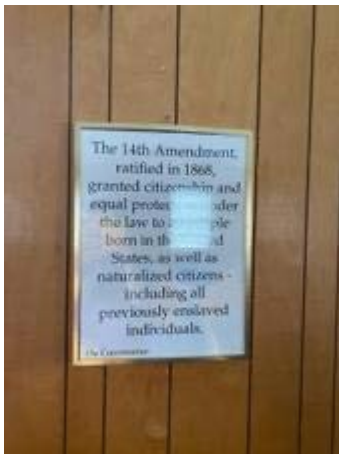
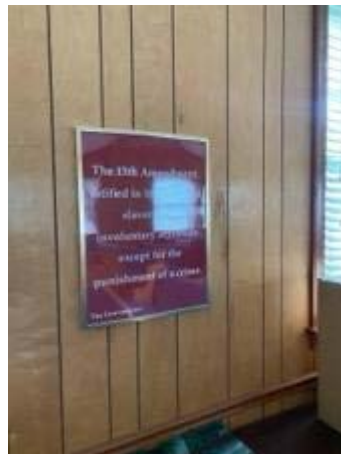
Deficiency: Wall canvases in the Learning Center need audio descriptions; pamphlets and posters in the hallway behind the stage need alternate format. The existing visual elements and

features within the Learning Center and surrounding grounds do not have corresponding audio components or audio description. This presents a barrier to full participation for visitors who are blind or have low vision, and for some individuals with cognitive impairments. The park does not provide a comprehensive audio description of the eight wall canvases and two hanging posters or self-guided tour information provided in the park unigrid brochure and mobile application. Audio description is necessary for visitors who have visual and cognitive impairments to gain an equal understanding of the subject matter.

Brief Description: Redesign of interpretive exhibits at Learning Center
